BURNED AREA EMERGENCY RESPONSE (BAER)

Smith River Complex Post Fire BAER Assessment August-September 2023

Six Rivers & Rogue River-Siskiyou National Forests

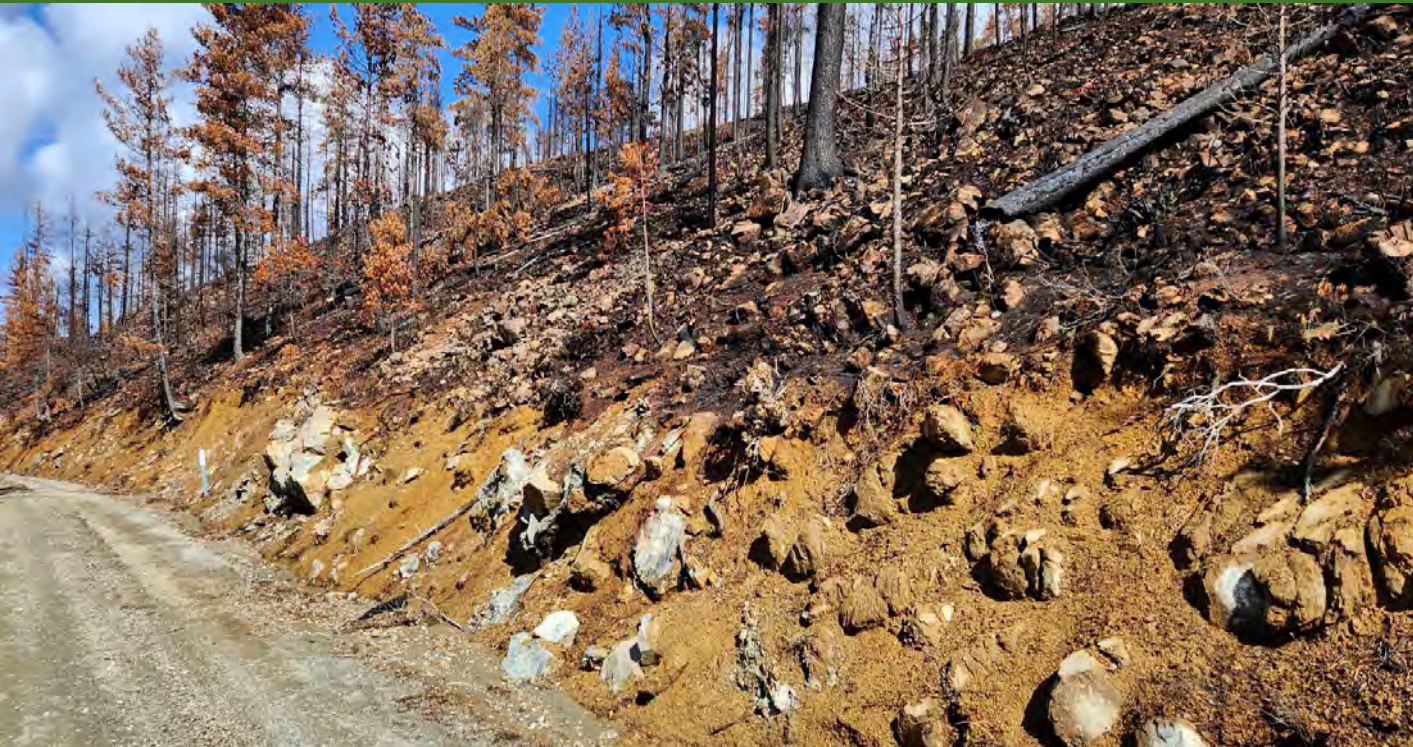
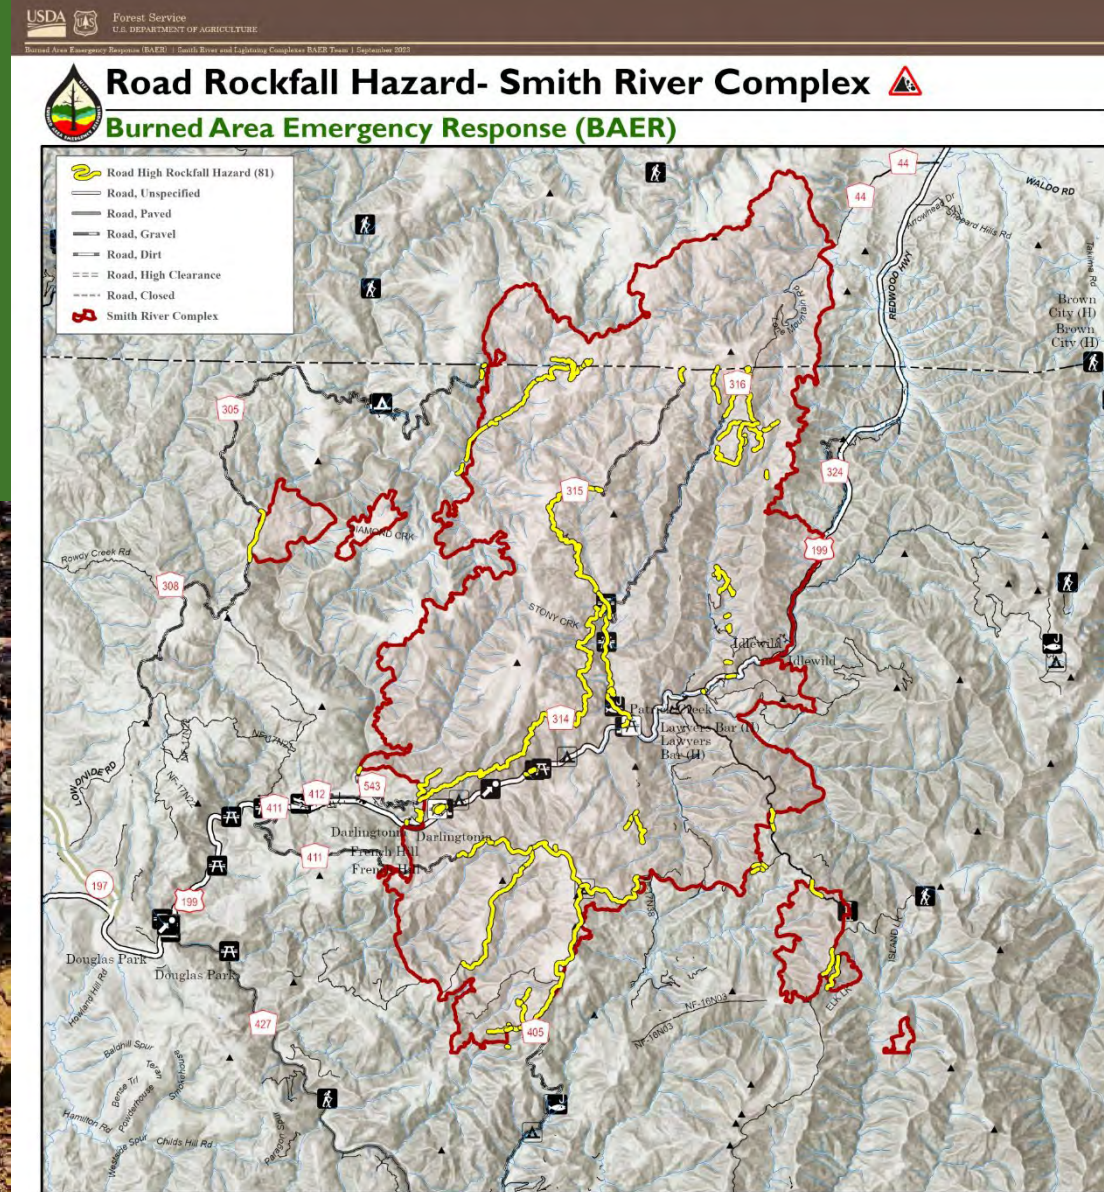
- Depending by the parent material, Some segments of roads present high potential for rockfall While other segments are void of any surface rocks.

- Coordinate warning notifications with the National Weather Service
- Post warning signs and enforce administrative closures
- Road storm proofing and storm patrols

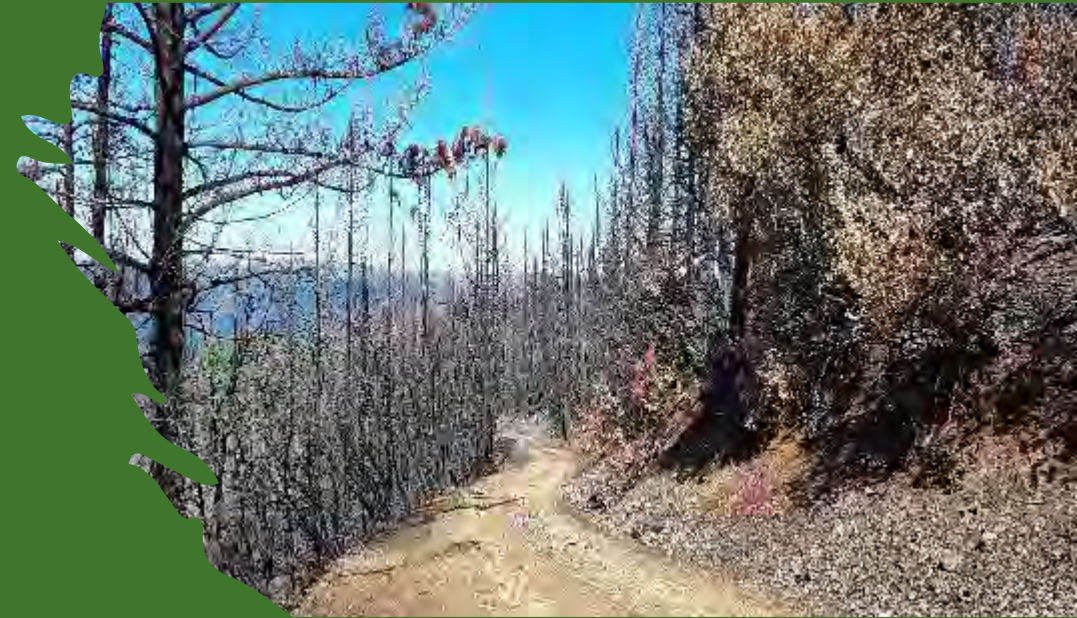
18N17 ridge near repeater

- 67.9 miles of the roads burned in Moderate or High Soil Burn Severity areas
- Erosion exacerbated by rainstorms that occurred after the fire
- Future storms could lead to erosion that damage culverts which lead to road failures

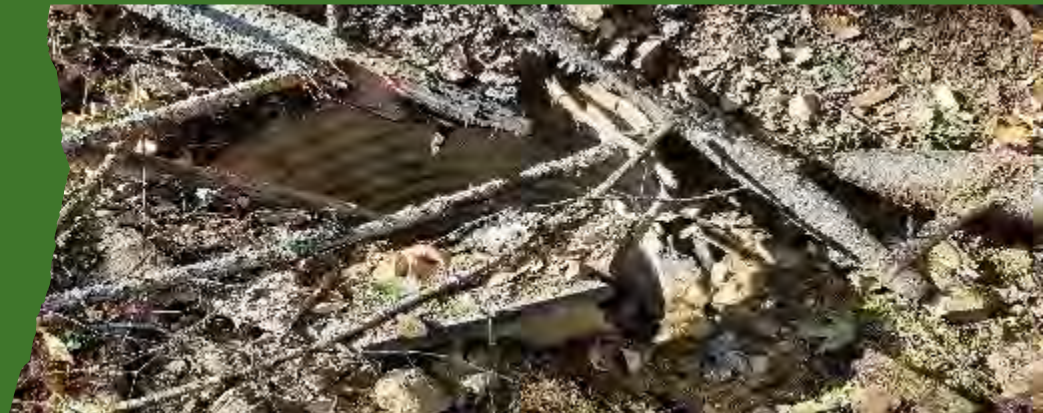
Plugged Culvert

- Road Loss
 - Rain events creating high erosion potential to block culverts leading to road failure
- Human life and safety
 - Rain events putting debris on the road leading to closures, destroyed roads, and potential for human loss
 - Hazard trees along roads

Treatment	Units	# of Units
R1. Storm Proofing	Miles	44.9
R1. Clear Culvert Inlet Basin	Each	9
R2.a Drainage Dip (10CY Riprap)	Each	36
R3. Storm Inspection & Response	Miles	23.2
R3. Storm Response w/ Heavy Equipment	Each	4
R5. Critical Dip	Each	2
R6. Culvert Mod – Riser Pipe	Each	46
R13. Shoulder Burnout Repair	Each	55

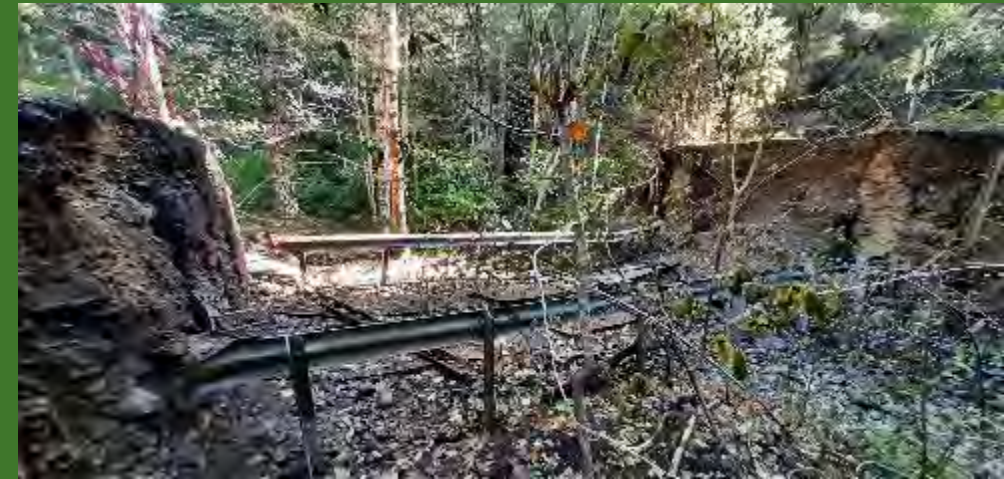
Burned Bridge

- Wood additions to Diamond Creek
- Remove/upsized certain culverts
- Mitigate cannabis cultivation sites
- Remove wood from burnt bridges
- Soil stabilization/planting if prescribed by other specialists

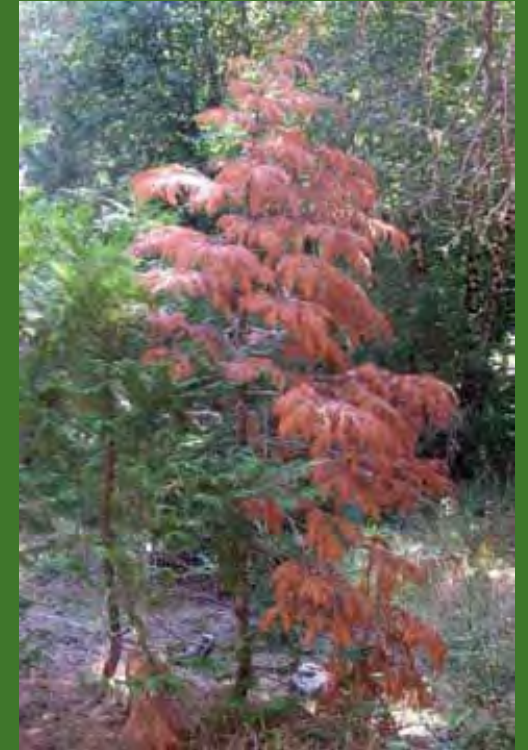
- Spread of Port Orford Cedar Root Disease and Sudden Oak Death
 - Introduction of invasive plant pathogens would cause loss of the critical natural resource values associated with native plant communities
 - Plant pathogen progression can lead to loss of shade canopy and overstory of Smith River and tributaries

Phytophthora lateralis
infected Port Orford cedar

- BAER Early Detection Rapid Response EDRR – invasive noxious weeds
- P1b Suppression Disturbance EDRR - invasive noxious weeds
- P3 Other Plant Treatments - Plant Pathogen Testing/Monitoring/Treatments

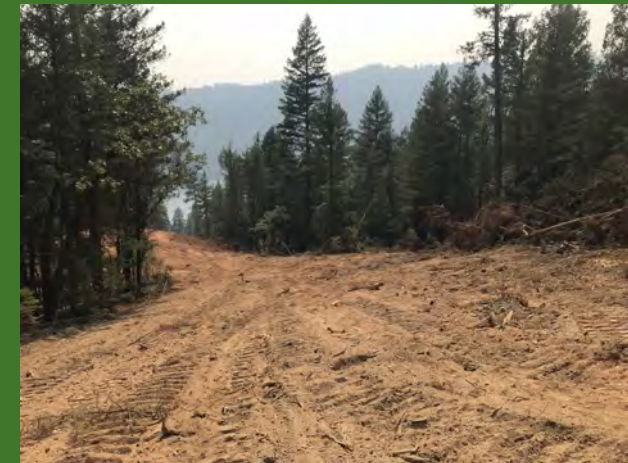
Dozer line disturbed ground

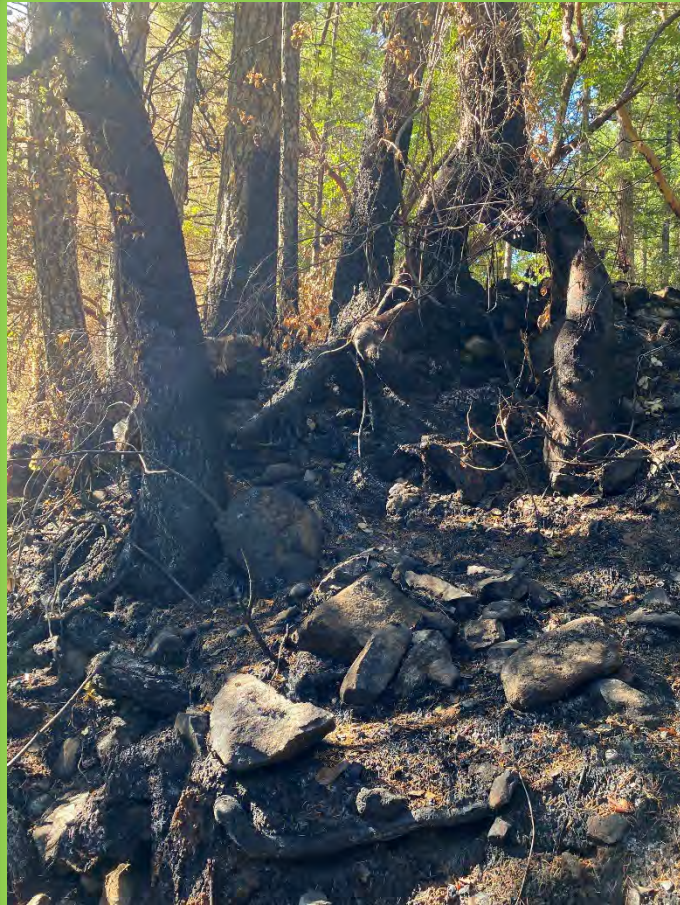
Patrick Creek Campground 2 levels of threat

Burned
Hazard
Trees
around
historic
features

Hydrological
models
project
accelerated
erosion of
historic
masonry
along stream
(historic
swimming
area)

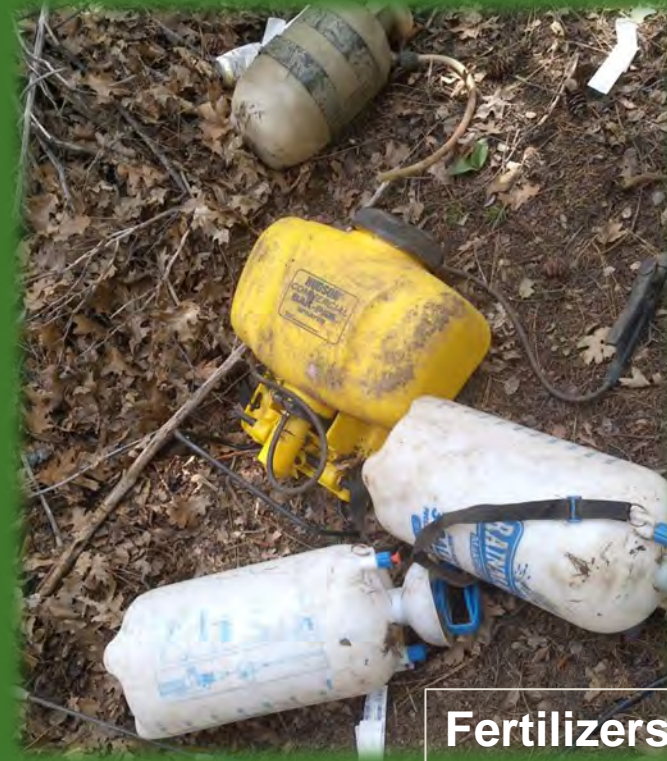
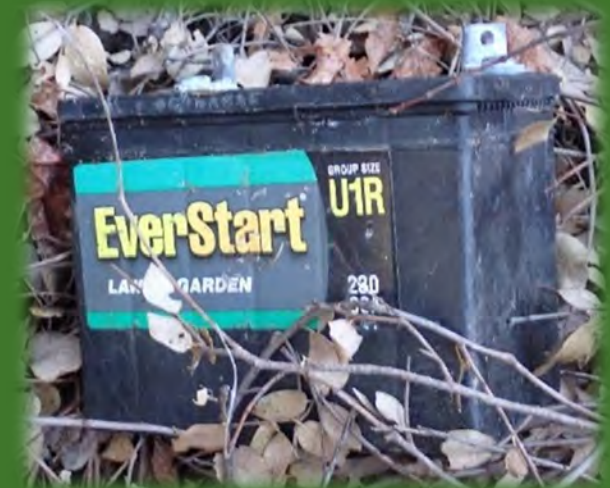
- 40 in Pacific Marten Suitable Habitat
 - 3 in Northern Spotted Owl Core Habitat
 - 24 in Coho Salmon Occupied Waters
-
- 100% Sites in R5 have Pesticides
 - 80% have Banned Pesticide
-
- Fire Exacerbates the Problem
 - Flames Compromise Containment
 - Hazmat Containment gets Liberated
-
- SBS Exposure & Transport
 - Erosion transports
 - Footprint Increases
 - Soils & Water Contaminated

Fertilizers, Batteries Pesticide Sprayers

- Hazmat Stabilization
 - LEI hazmat team or contractors stabilize, contain, mitigate, & transport for disposal
- 24 Sites Selected to Prioritize
 - Coho salmon drainages
 - Grouped sites for greatest number & least amount of days
- Multiple Benefits from Removal of Hazmat
 - 100% Owl core habitat improved
 - 16,000 acres Marten habitat improved
 - 16,515 acres of recreation, hunting & gathering improved
 - Public health & safety improved
