**Basis of Design Report for the
Upper Tryon Creek Stream Enhancement Design Project
Smith River, California**

July 10, 2020

**California Department of Fish and Wildlife
Fisheries restoration Grant Program (FRGP Agreement No. P1810510)**

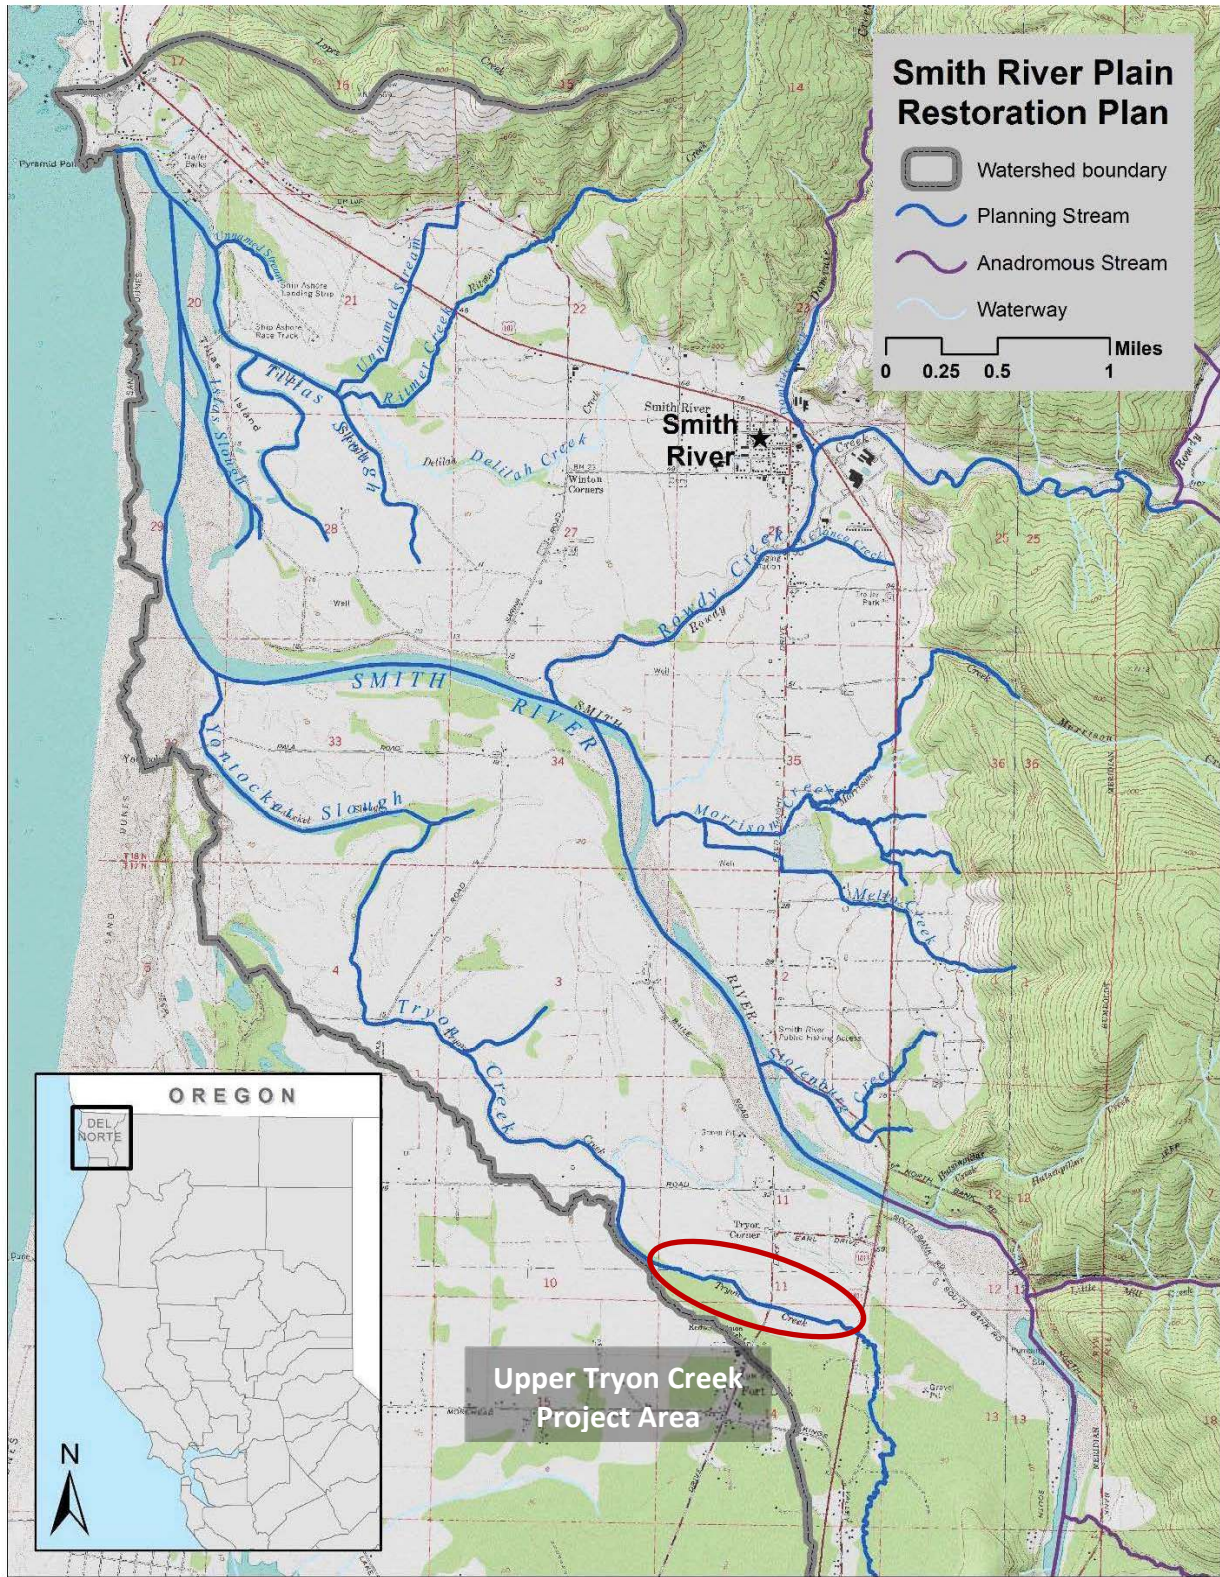
Figure 1-1. Plan view map of Tryon Creek (adapted from Parish, 2018). Approximate project area is circled.

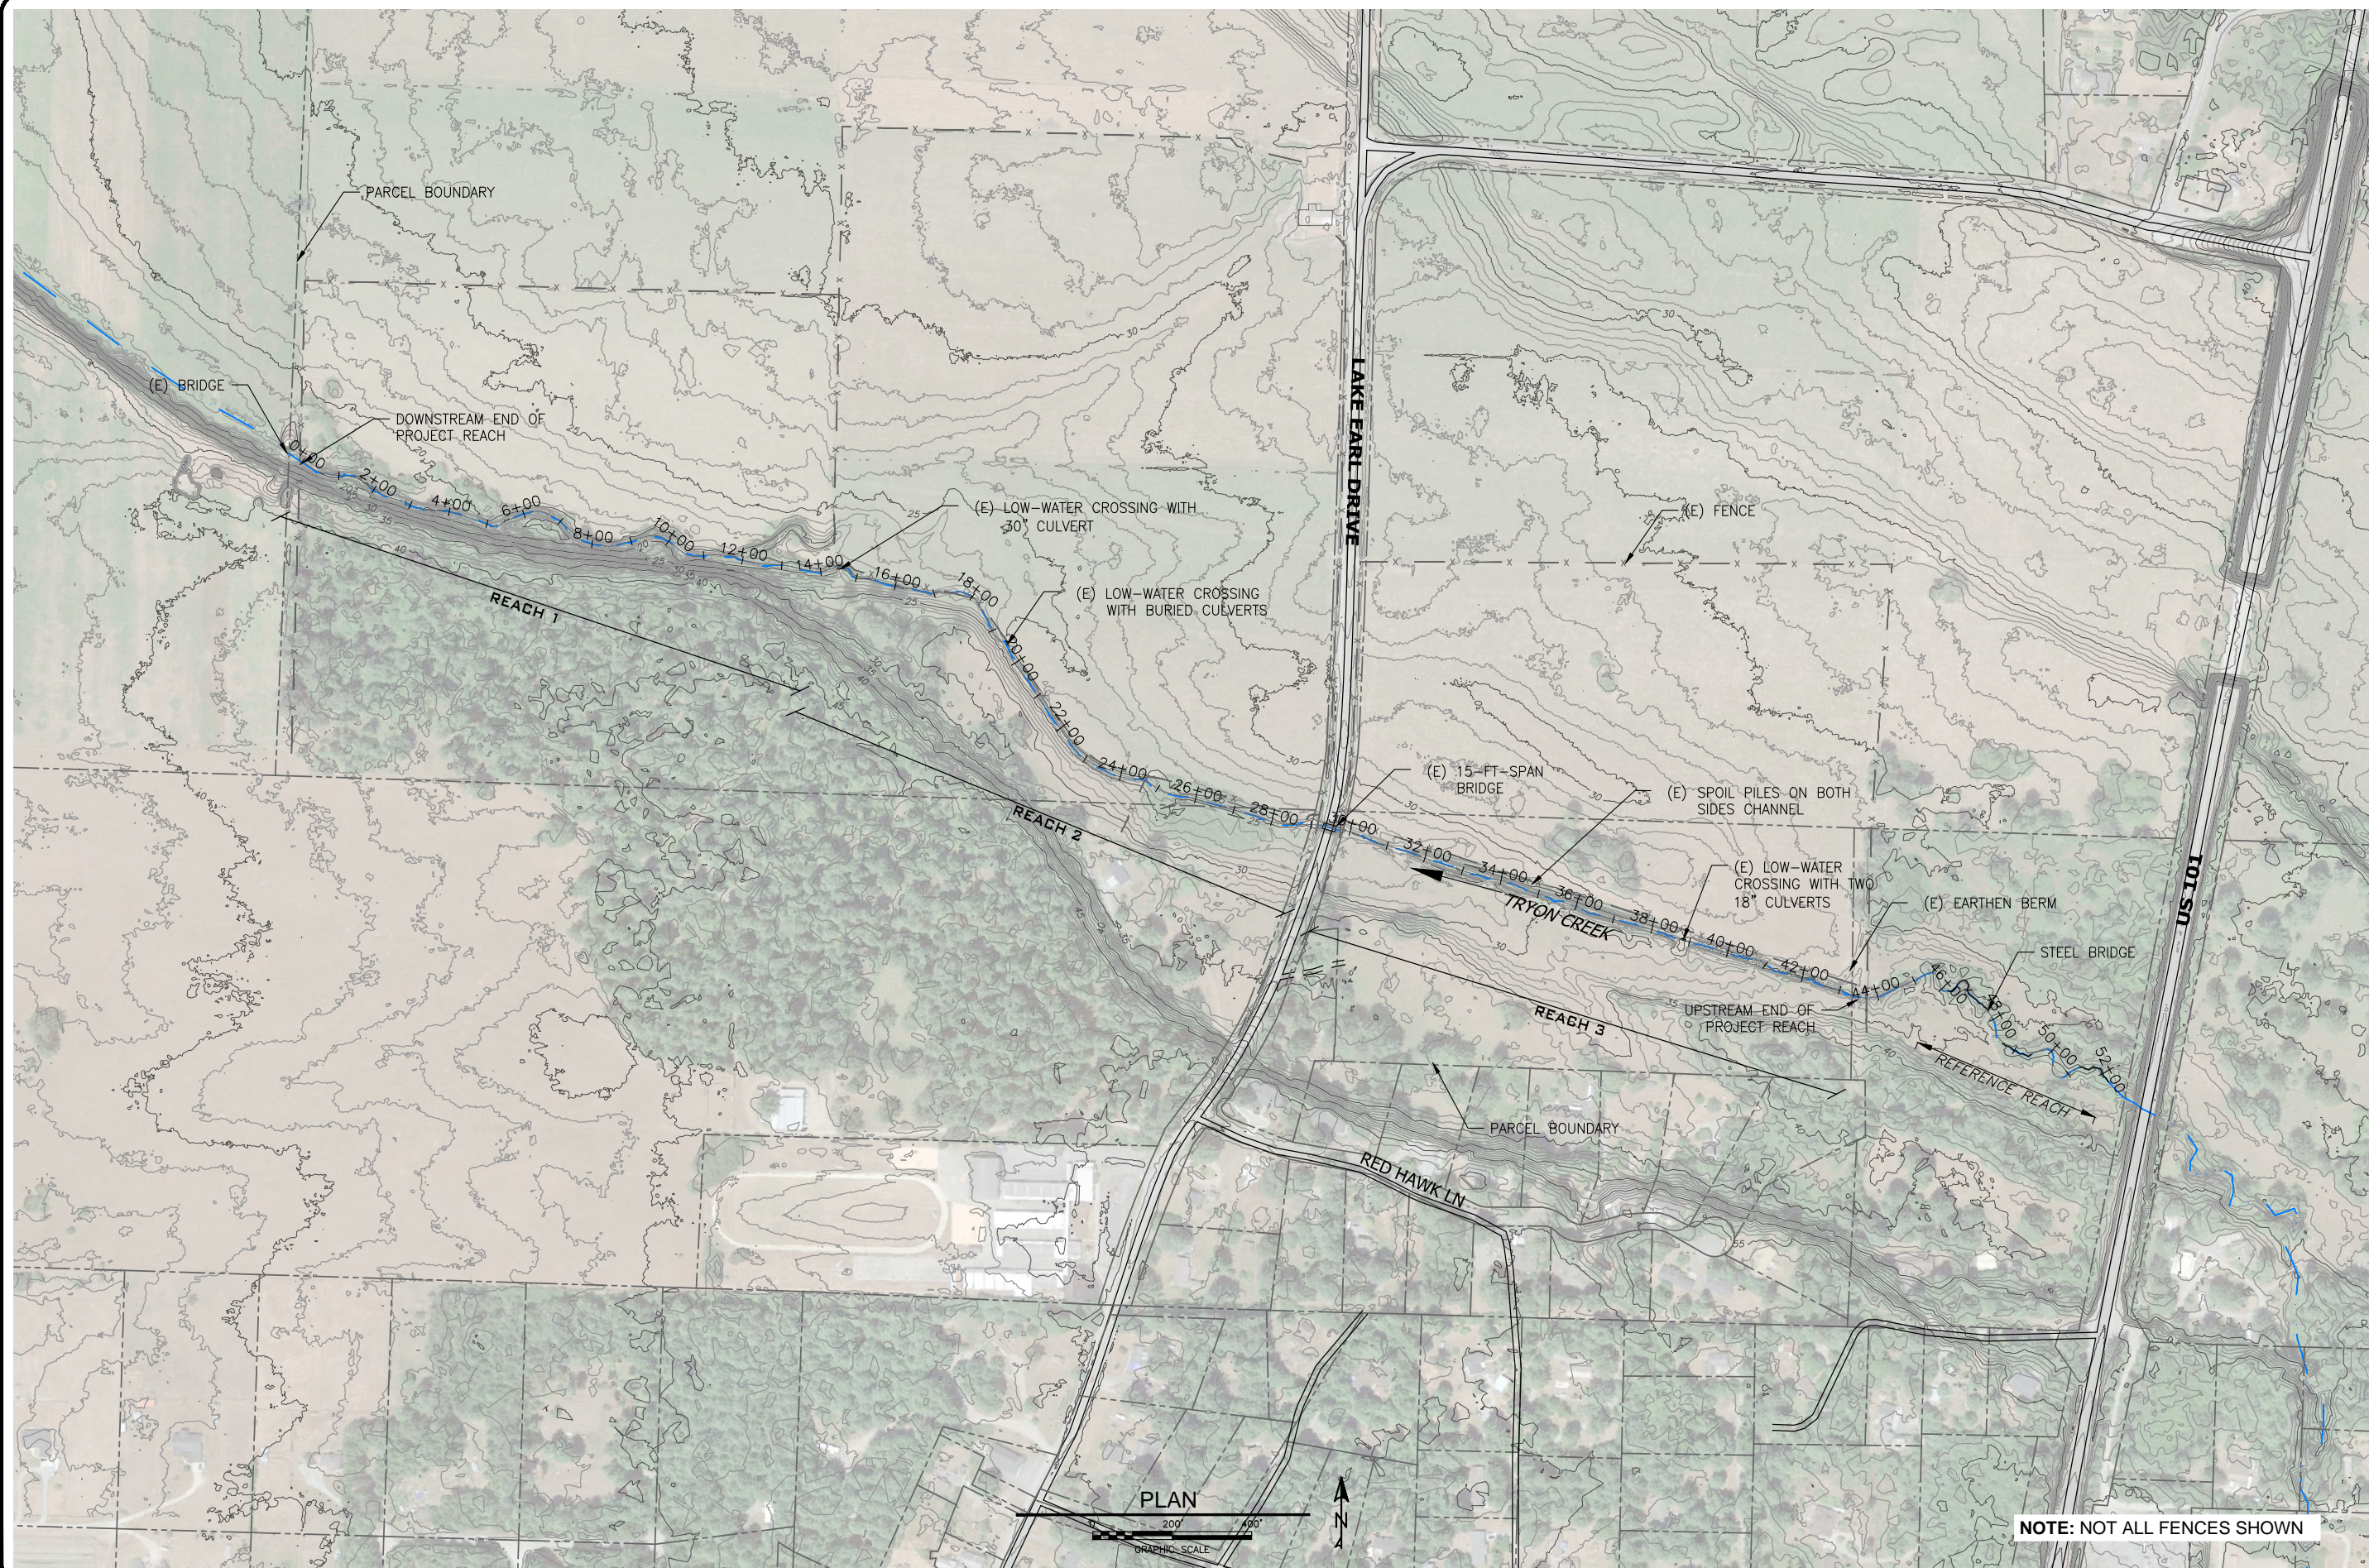
PLAN

The LiDAR and field-run topographic survey were merged to create a combined digital terrain model (DTM) and basemap of the project area with 1-foot contours, as shown on Figure 2-1. Approximate parcel lines were obtained from the Del Norte County geographic information services website.

A stationed channel centerline alignment was developed, with stationing starting at the property boundary at the downstream end of the project (just upstream of the neighbor's bridge) and increasing upstream to Highway 101. Figure 2-1 shows a plan-view map and Figure 2-2 shows a thalweg and floodplain profile of the project area of Tryon Creek, including the reference reach.

Figure 2-1 shows a plan-view map and Figure 2-2 shows a thalweg and floodplain profile of the project area of Tryon Creek, including the reference reach.

It is evident on the ground and in the LiDAR and aerial photography that there was once a sinuous channel located slightly to the south of the current channel (Figure 2-1). The old channel is mostly filled in, but consist of a low area that is wetter than the surrounding ground. See Section 2.5.2 for additional detail.

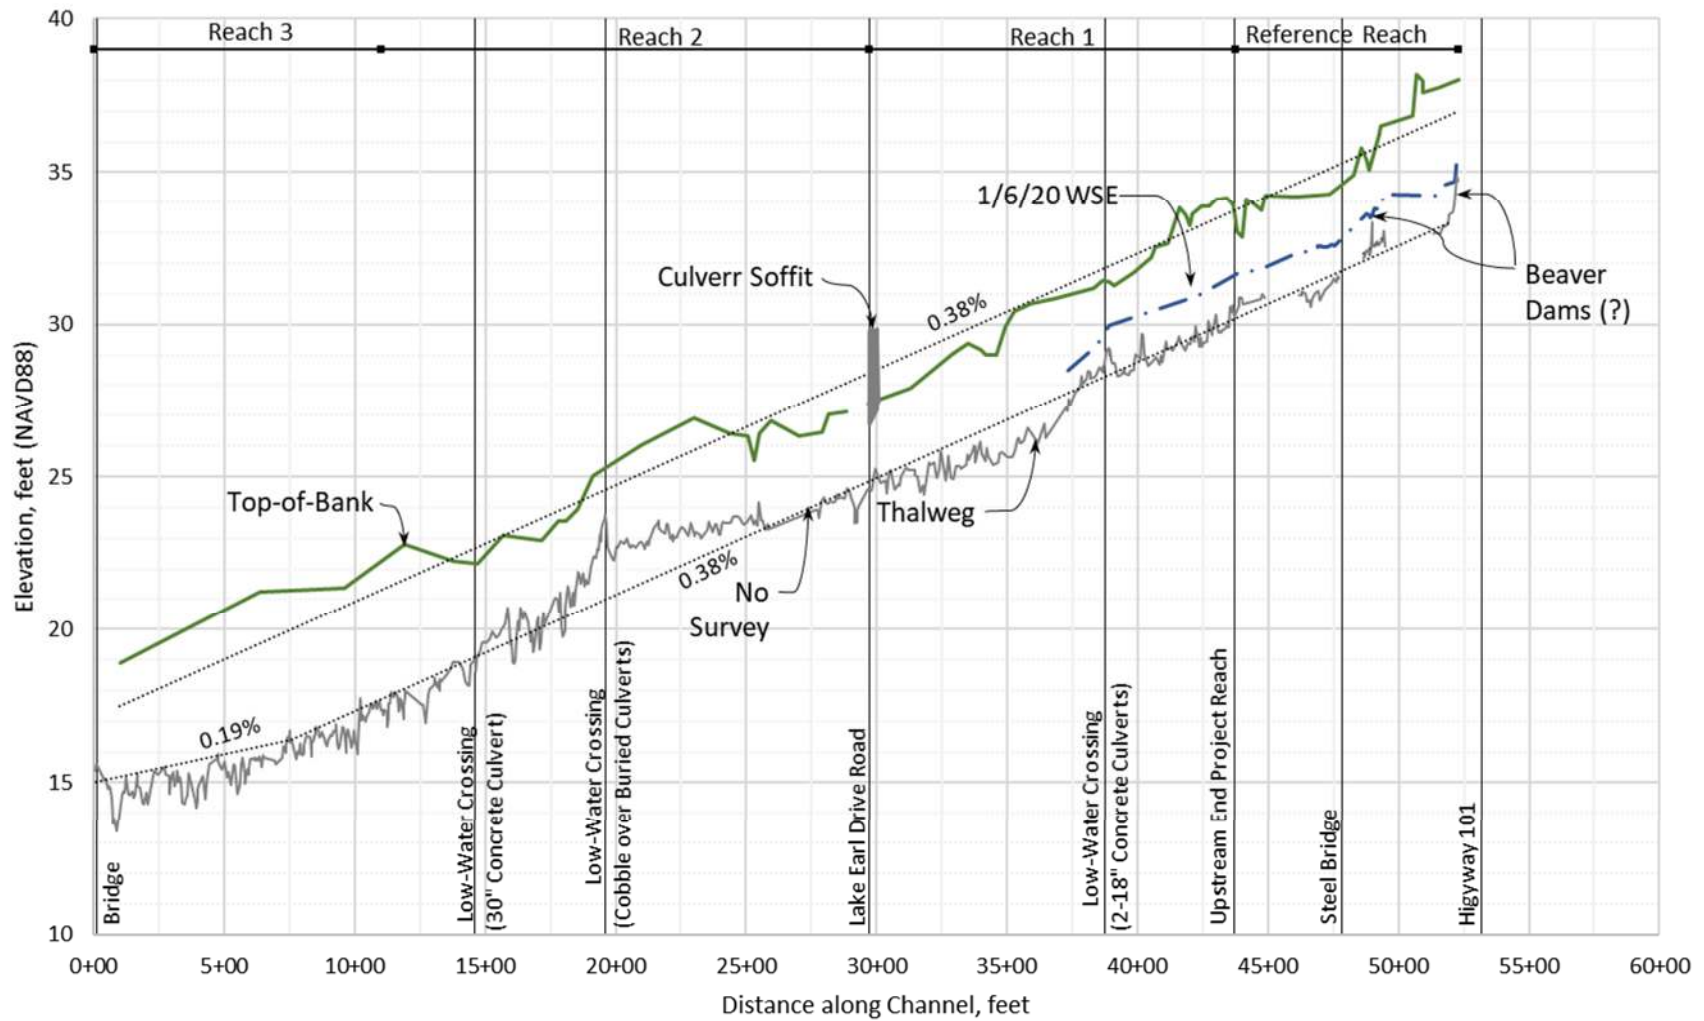
Figure 2-2. Channel and floodplain profile of the project area and reference reach of Tryon Creek, with overall slopes provided. Water surface elevation (WSE) profile shown in the upstream end of the project reach and in the reference reach.

As shown in Figure 2-2, the channel thalweg and the floodplain in the reference reach have an overall slope of 0.38%, the same slope as the project reaches (except downstream of station 7+00). There is little channel profile variability, with pools typically less than 1 foot deep, with the depth likely limited due to the stiffness of the clay substrate. Despite the channel thalweg profile having little variability, there are numerous partially spanning downed limbs and small debris jams that cause a high level of planimetric and flow complexity. Near the upstream limit of the reference reach there appeared to be at least two beaver dams that spanned the channel, causing a backwater upstream and about a 1-foot drop in the water surface profile.

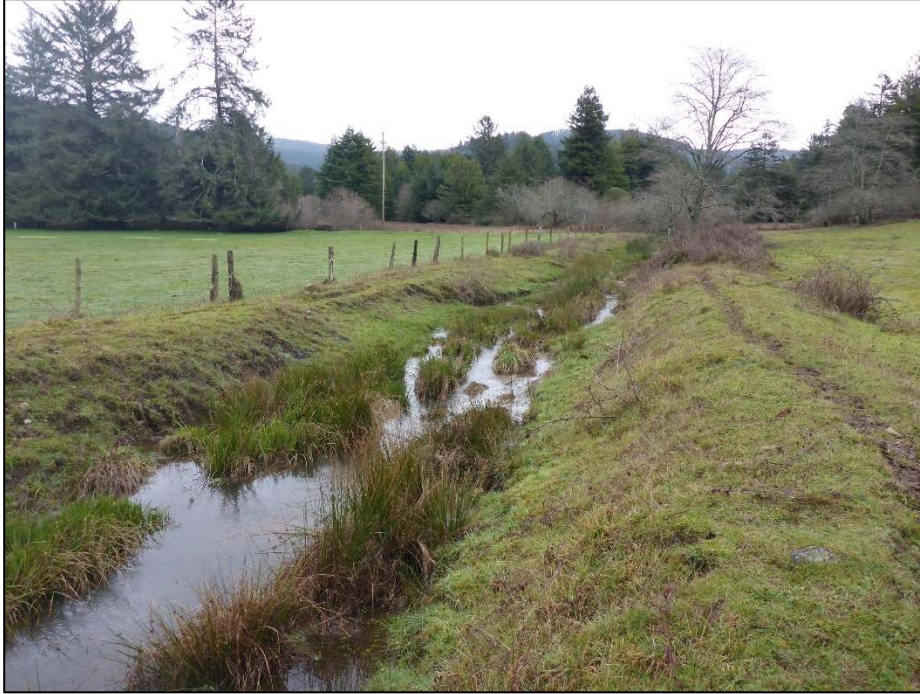
Figure 2-3. Tryon Creek project reach upstream of Lake Earl Drive (looking upstream). The stream channel has been ditched and straightened, with discontinuous spoil piles on both sides of the channel (Photo date January 2020).

The channel remains ditched and straightened for about 1,600 feet downstream of Lake Earl Drive, though there are only occasional spoil piles adjacent to the channel in this reach (Figure 2-5). The channel is typically trapezoidal in shape with a bottom width that varies from 9 to 14 feet and a 2- to 3-foot deep bankfull depth before flows spill onto the floodplain. Grasses within the channel cause high flow resistance.

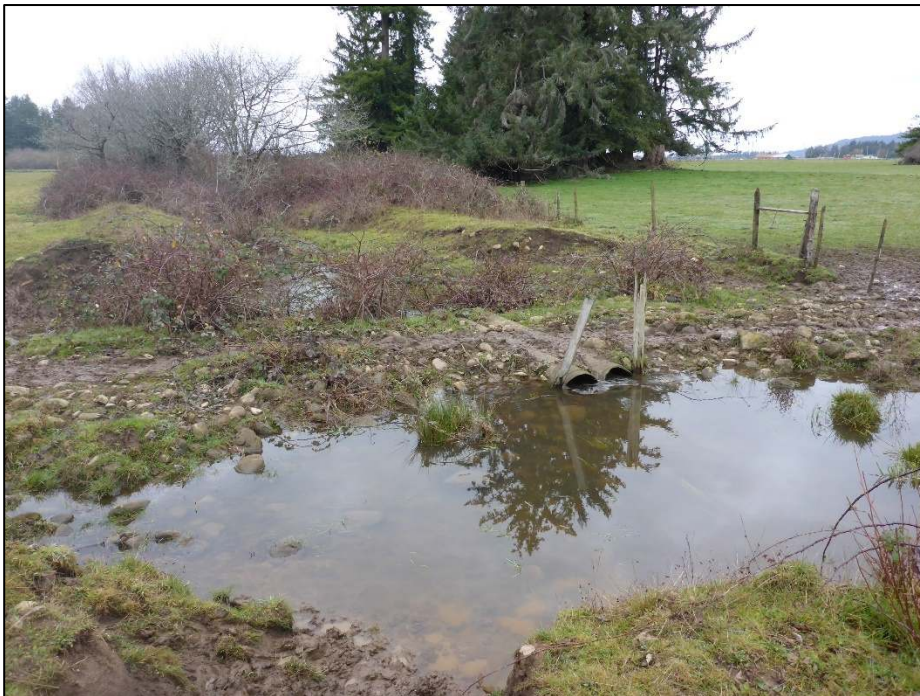
Figure 2-4. Livestock crossing upstream of Lake Earl Drive (looking downstream) consisting of two 18-inch concrete pipes surrounded by placed cobble. (Photo date January 2020).

There is a low-water crossing near station 19+62, which consists of concrete pipes buried by a thick layer of salvaged cobbles that extend for a distance downstream of the crossing (Figure 2-6). As evident in the photograph and on Figure 2-2, the crossing is about a foot higher than the upstream channel bottom. When the stream is flowing, the crossing creates a backwater and a steep riffle over the top and downstream of the crossing. It appears that some aggradation may be occurring upstream of the crossing.

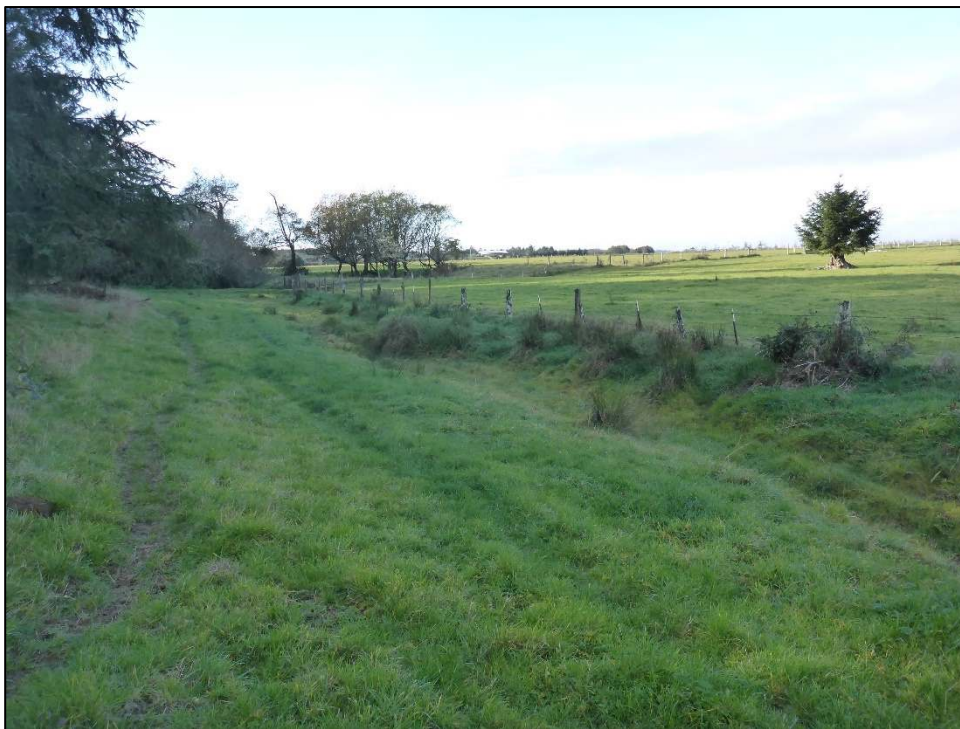
Figure 2-5. Ditched and straightened channel in Reach 2, downstream of Lake Earl Drive (looking downstream) (November 2019).

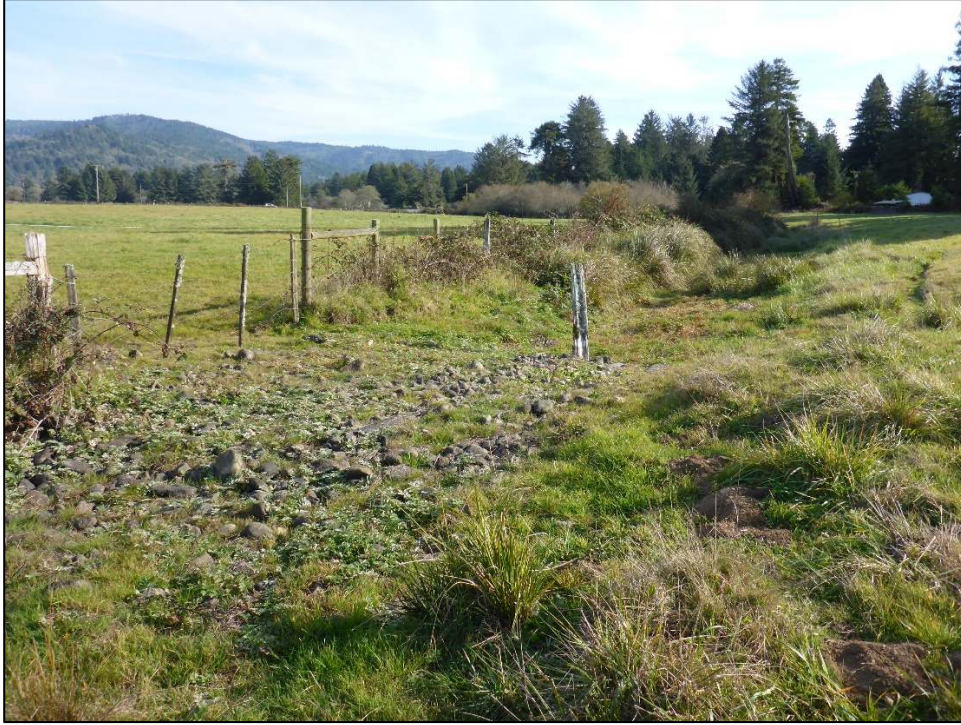
Figure 2-6. Low-water crossing with buried culverts overlain by placed cobbles, located in the middle of Reach 2 (looking downstream). (November 2019).

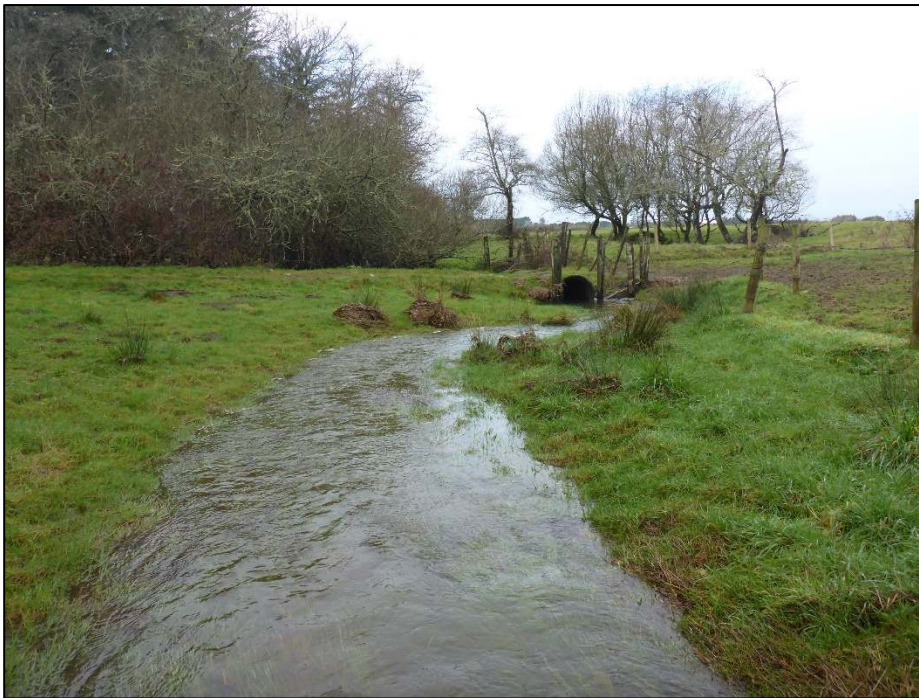
Figure 2-7. 30-inch culverted low-water crossing near the downstream limits of Reach 2 (looking downstream). (January 2020).

Near station 14+00 there is a 30-inch diameter concrete culvert forming a “vented” low-water crossing (Figure 2-7). Though narrower than the channel bottom, the crossing does not seem to be affecting stream stability near the crossing. The culvert is in poor shape, with decoupled joints and cracking.

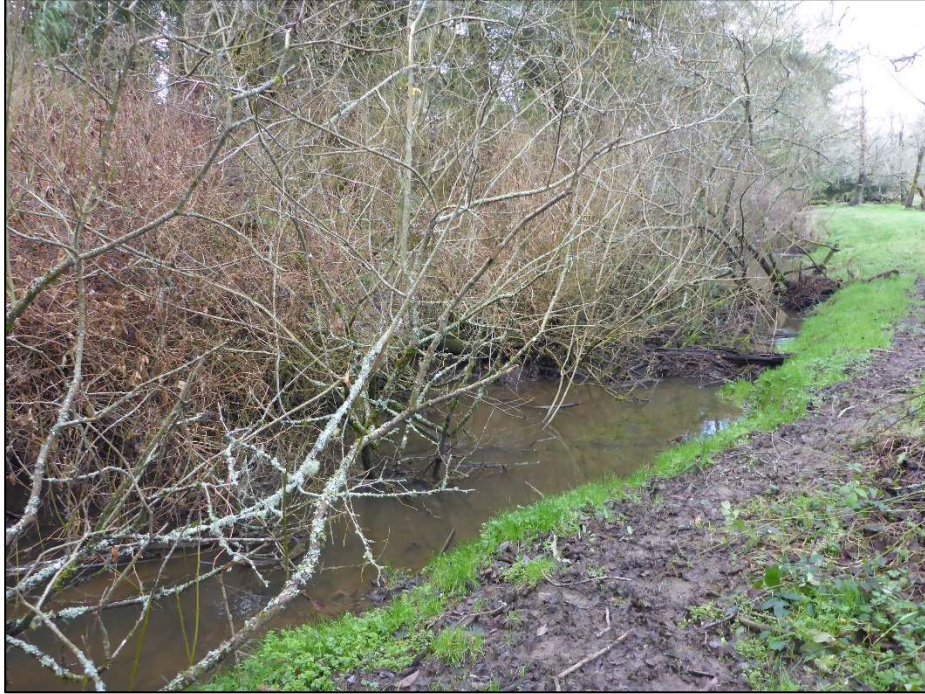
Figure 2-8. Channel flowing along base of hillslope in Reach 3 (looking downstream). (January 2020).

At about station 11+00, the channel begins to flow against the toe of a steep slope, which, as is visible on the LiDAR DTM, was once formed by a historical meander bend of the Smith River. The toe of this slope generally dictates the planform of Tryon Creek in this reach (Figure 2-8), except where two small meanders have formed near stations 6+00 and 10+00 (Figure 2-9). The channel retains its trapezoidal shape, but narrows to 8 to 13 feet, with occasional wider areas. The channel also deepens to about 4 feet before it flows onto the floodplain.

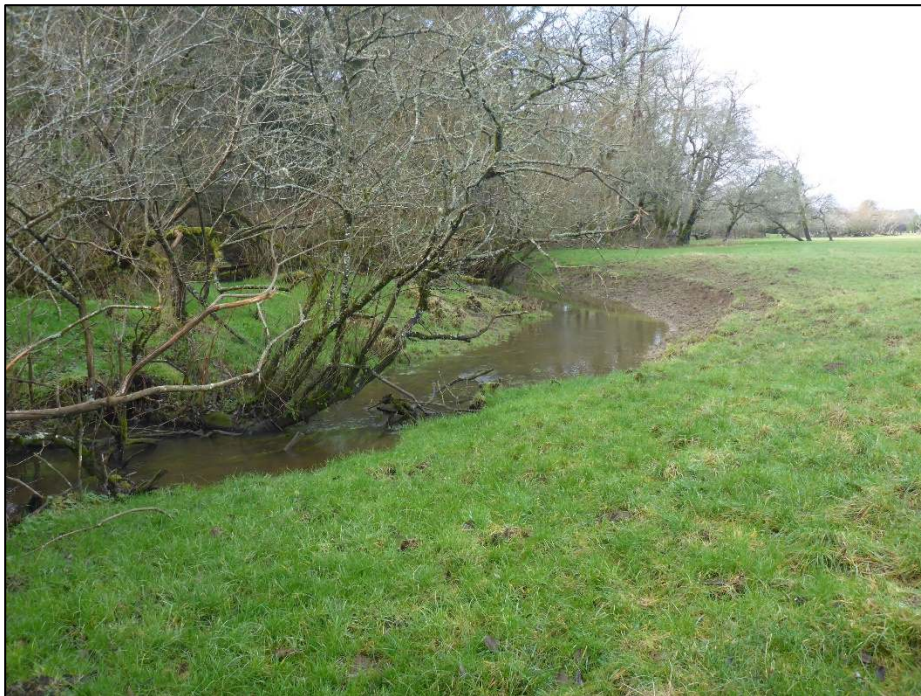
Figure 2-9. Channel in a meander bend in Reach 3 of the project area (looking downstream). (January 2020).

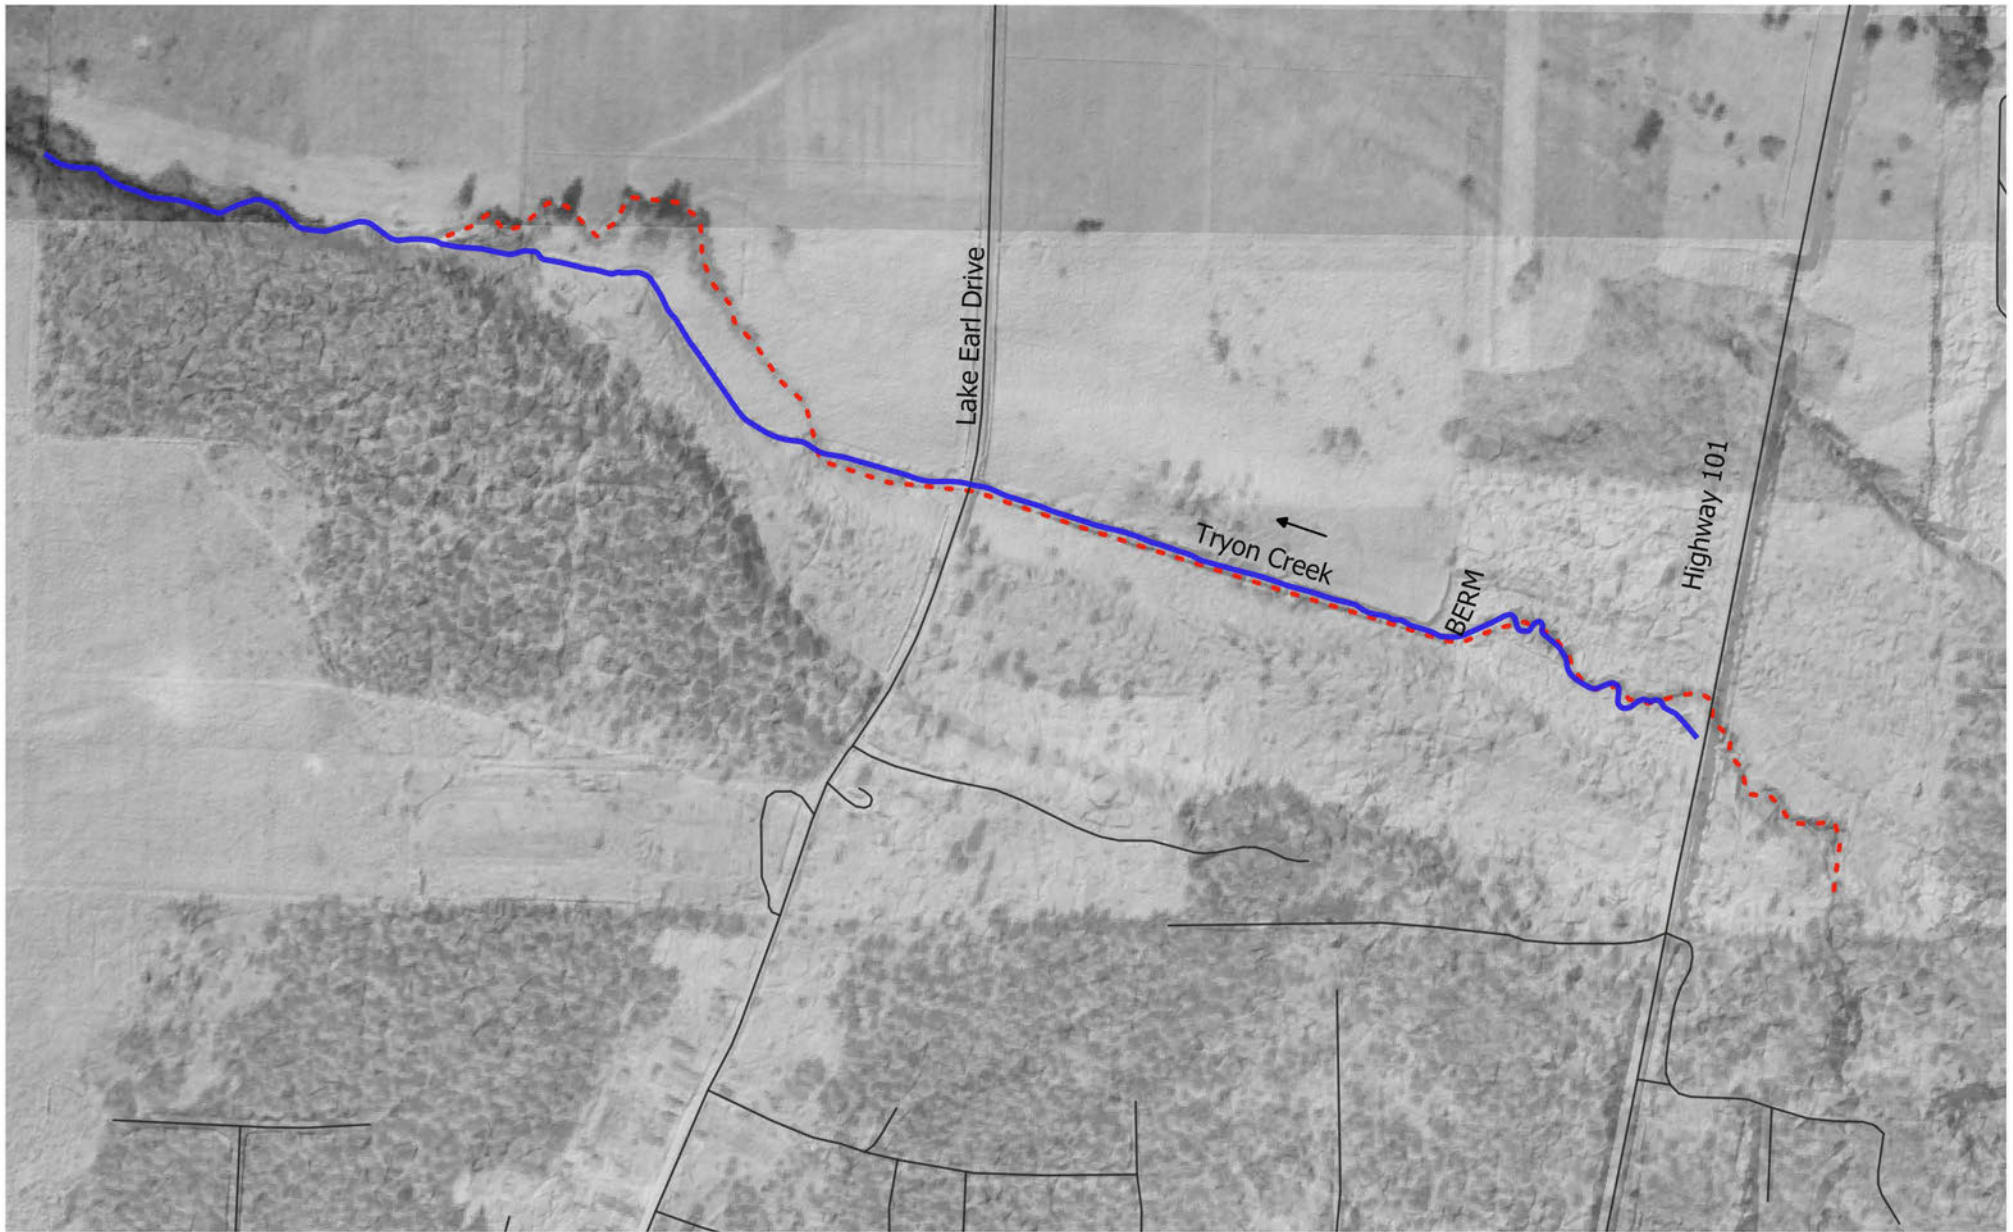
Figure 2-11
Historical Map Analysis
1942 Aerial Photograph and Stream Centerline

Downstream of Lake Earl Drive, the flow path traced on the 1942 aerial photograph continued to flow to the north of the existing channel alignment. This flow path ultimately merged with the current alignment of Tryon Creek in Reach 2, where it flows along the base of the hillslope along a historical meander scarp left by the Smith River. A separate channel alignment, evident on the 1958 aerial photograph, indicates that Tryon Creek once flowed along a sinuous channel close to the current channel alignment, but then turned to the north, meeting the trace of the channel evident on the 1942 alignment. The channel was ditched into its current alignment downstream of Lake Earl Drive sometime between 1972 and 1993.

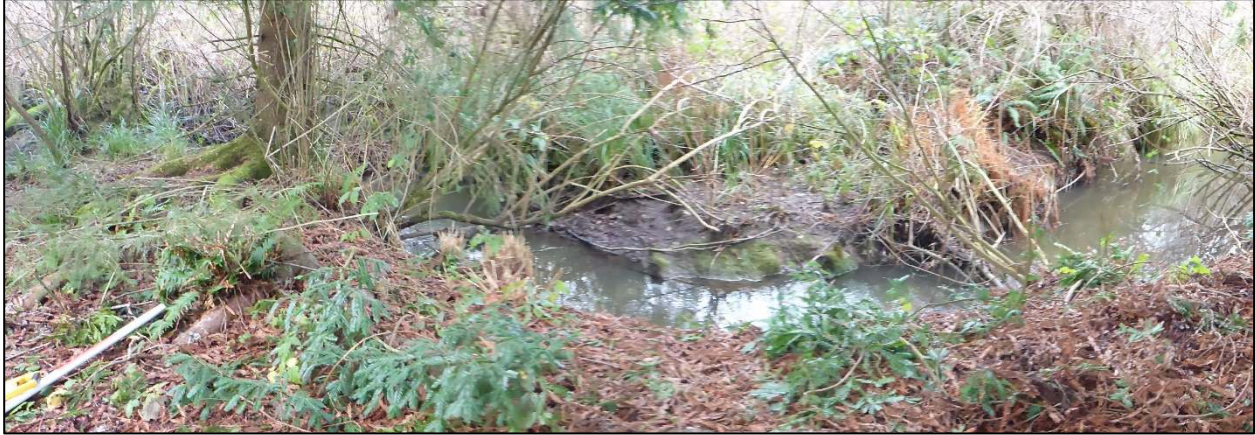
Figure 2-13. Typical sinuous channel and riparian area within the reference reach (Photo date January 2020).

The reference reach of Tryon Creek represents a typical forested floodplain channel flowing through fine cohesive sediments (Schumm, 1985). Generally, this type of channel flows out of bank fairly frequently, the channel platform is highly sinuous, and the channel profile controlled by cohesive materials, large wood, vegetation, and roots. Sediment transport occurs mostly as suspended and washload. Photographs of the reference reach are shown in Figure 2-13 and Figure 2-14.

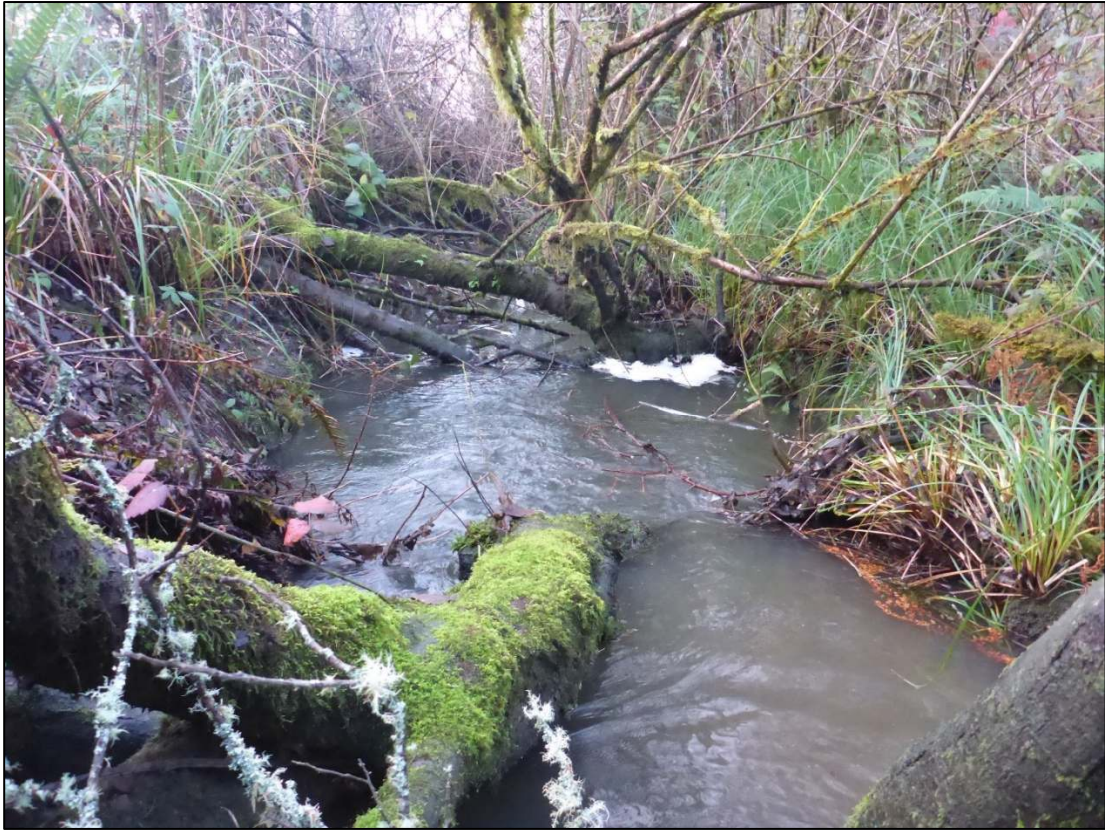
Figure 2-14. Partial to full-spanning wood and debris jams are common in the Tryon Creek reference reach. (January 2020).

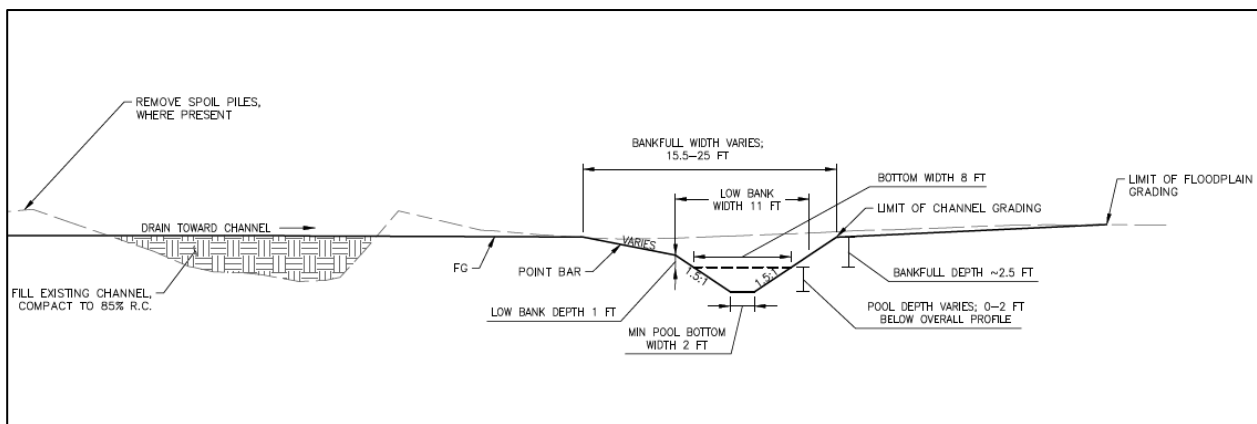
Figure 3-1. Typical design cross section for Tryon Creek.

The design bankfull width will be 15.5 feet wide, widening to about 25-feet wide at meander bends where a point bar will be graded on the inside of the meander bend. The point bar design was obtained from the dimensions of the low benches observed in the reference reach.

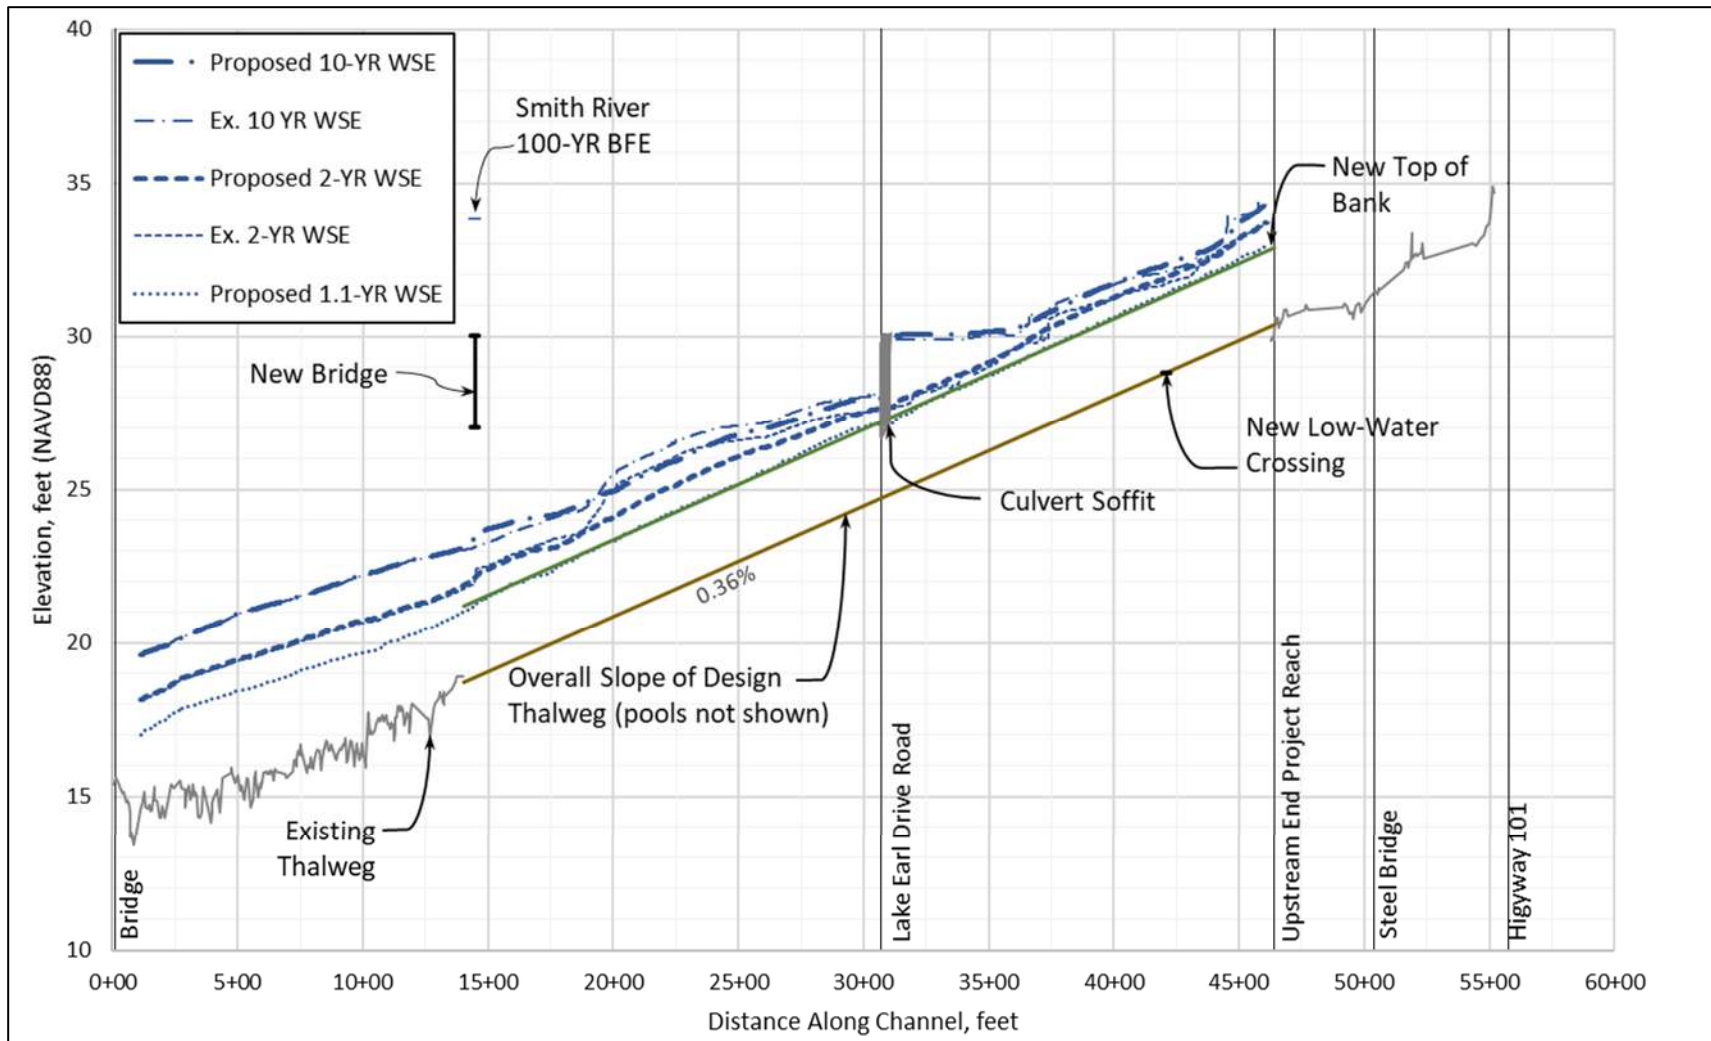
Figure 5-4. Design profile for Tryon Creek with model-predicted 1.1-, 2- and 10-year water surface profiles for existing and proposed conditions. For clarity, the existing condition 1.1-year model results are not shown.

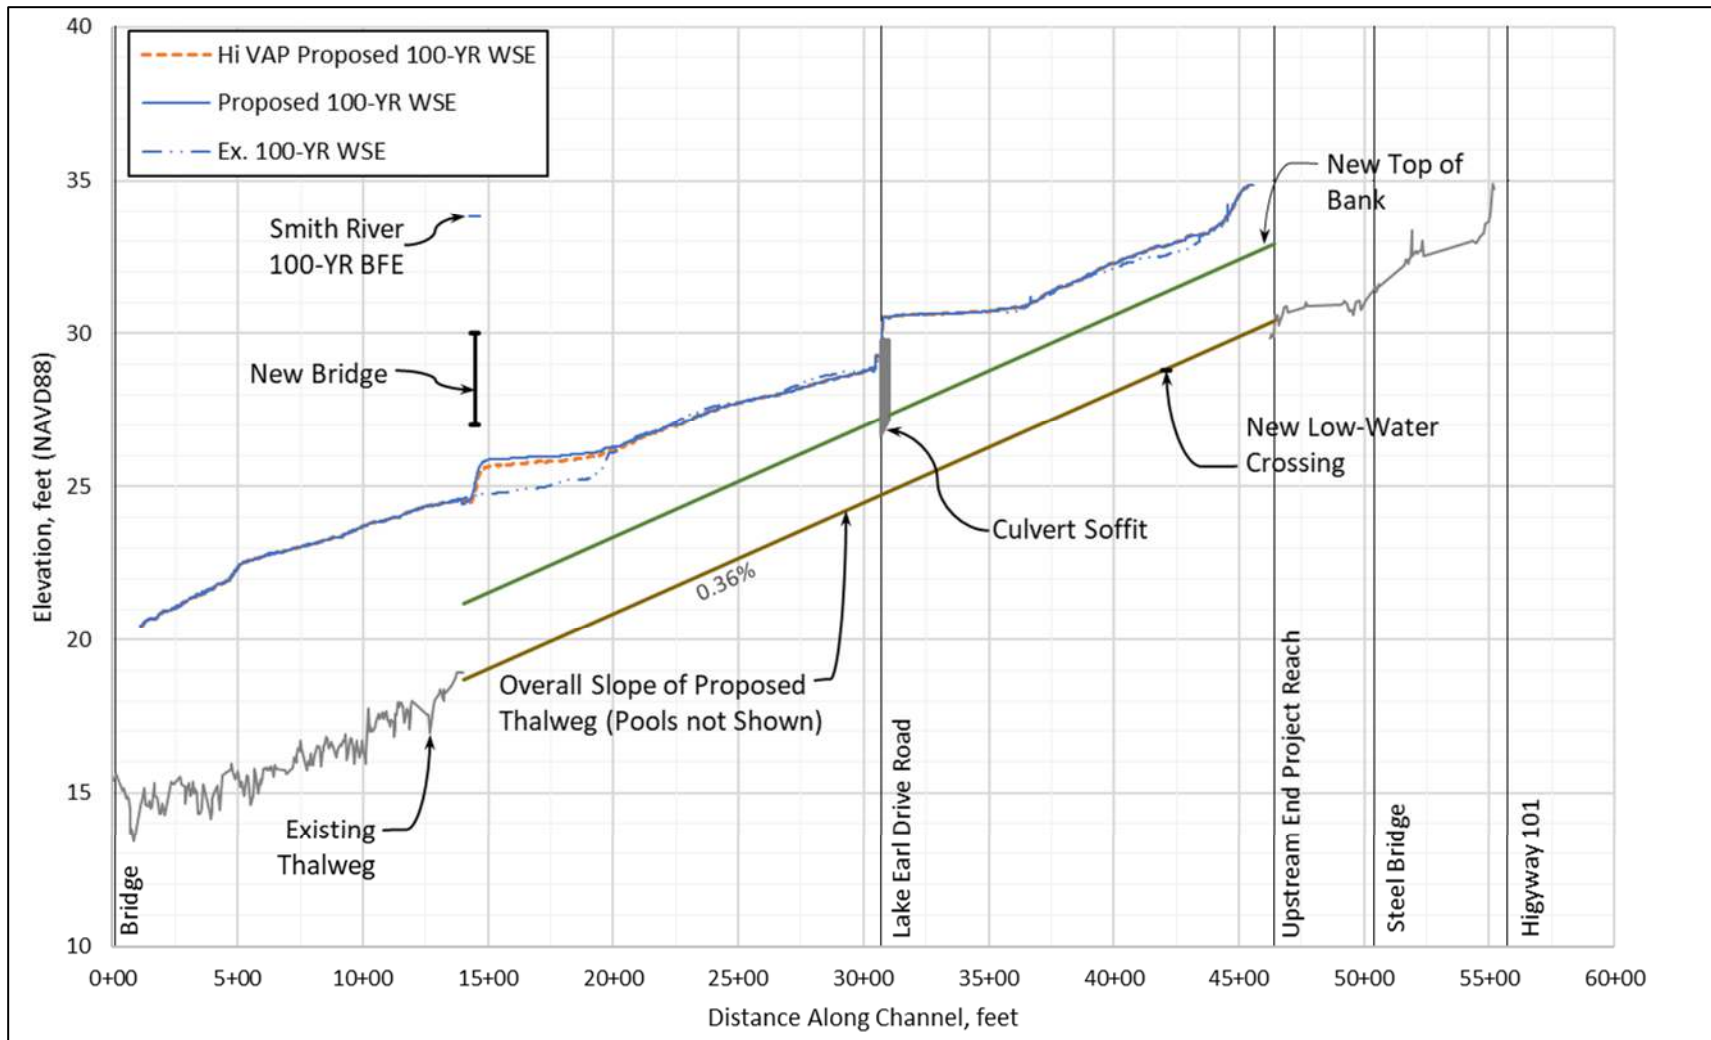
Figure 5-5. Design profile for Tryon Creek with model-predicted 100-year water surface profile for existing and proposed conditions.

Figure 5-5 indicates the project can be expected to slightly increase Tryon Creek 100-year water surface elevations in localized areas upstream of Lake Earl Drive. This increase in water level is not expected to extend upstream to Highway 101. The new bridge and associated approaches will cause slightly more than 1-foot of increase in the 100-year water surface elevation extending about 500 feet upstream of the bridge, but this rise will not extend to Lake Earl Drive.
