### **Liaison Update #3**

**OES Report # 22-2410:** Updated 5/23/22

Name of Incident: Smith River Incident

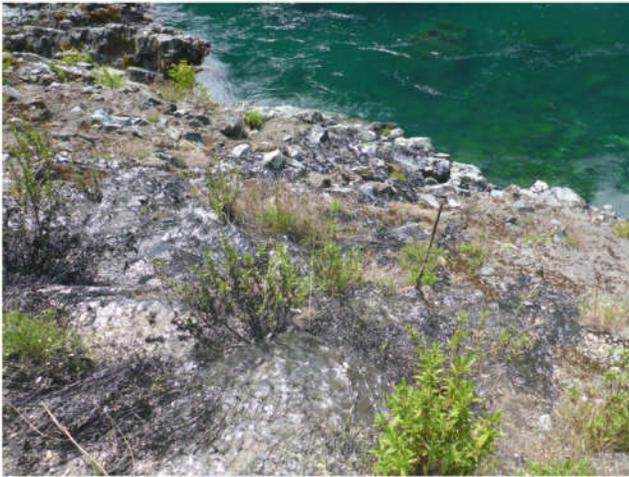
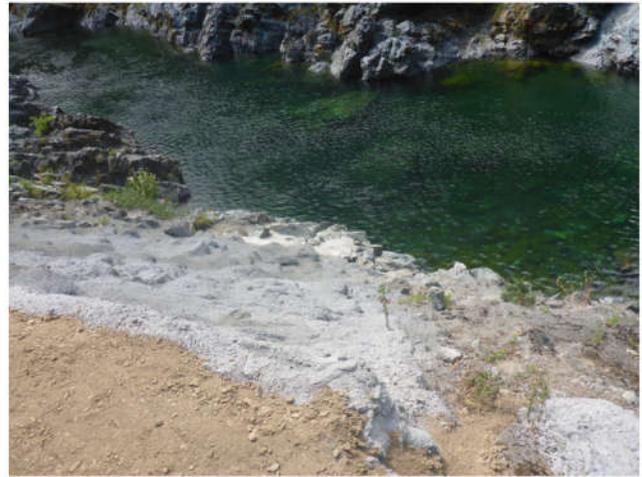
Spill Site - #1: View from Highway 199 looking down the slope at the Smith River.

- Signoff of the spill site occurred 7/6/22 and the contractor has reapplied shotcrete to the slope. Before and after pictures are found below.
- Two teams of Ancon Services contractors continue to recover tarballs and patties from the shoreline from the spill site downstream to the Hwy 101 bridge. Oil continues to be recovered as the river recedes exposing gravel bars for search and collection of spilled material.

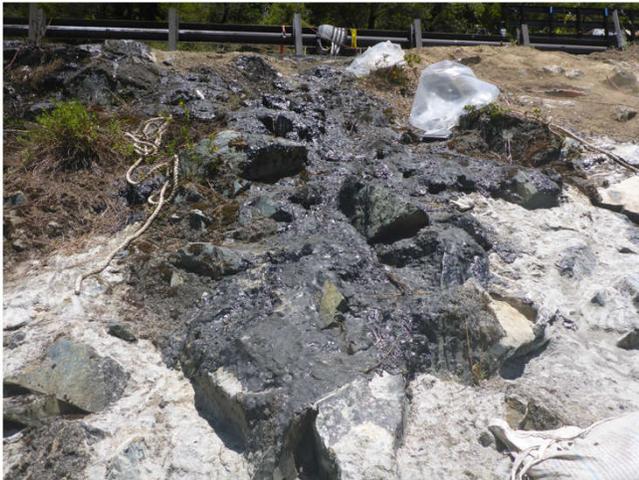
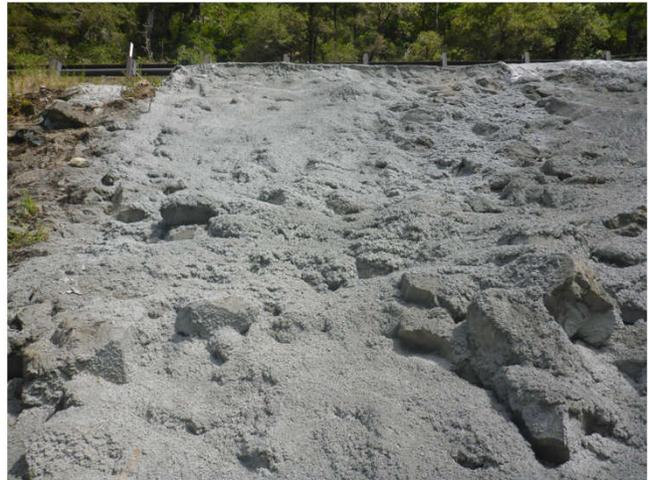
Spill Site - #2: View from Highway 199 looking downhill at the Smith River.

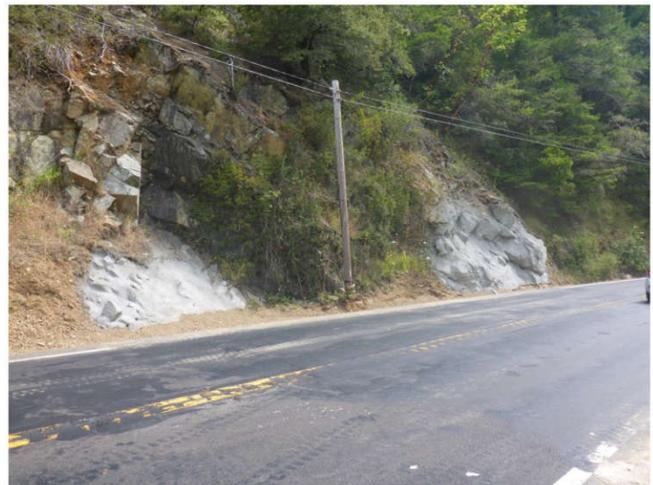
Spill Site - #3: View from the riverbank looking uphill toward Highway 199.
