BURNED AREA EMERGENCY RESPONSE (BAER)

Smith River Complex Post Fire BAER Assessment August-September 2023

Six Rivers & Rogue River-Siskiyou National Forests

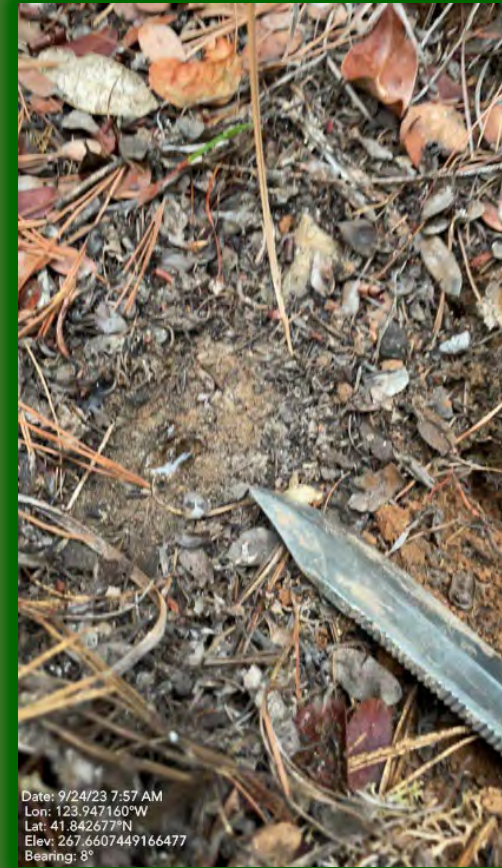
Unburned

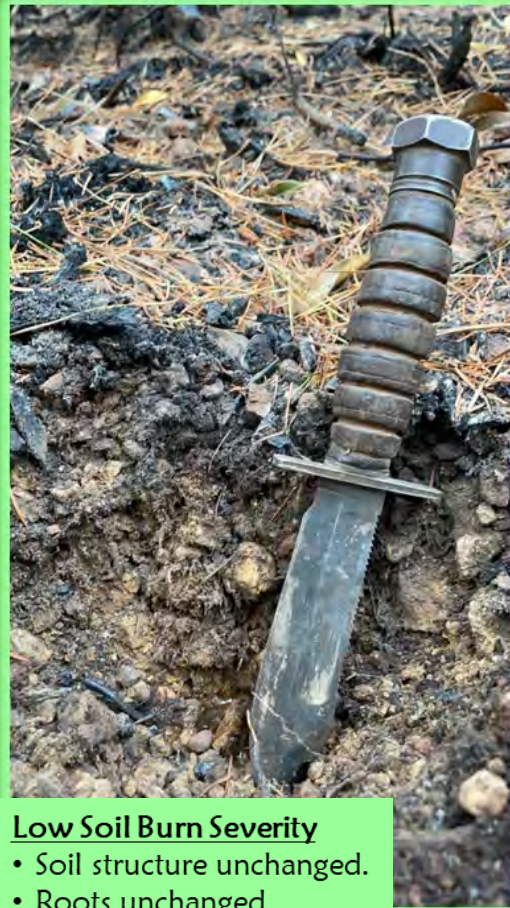
Low Soil Burn Severity

- Soil structure unchanged.
- Roots unchanged

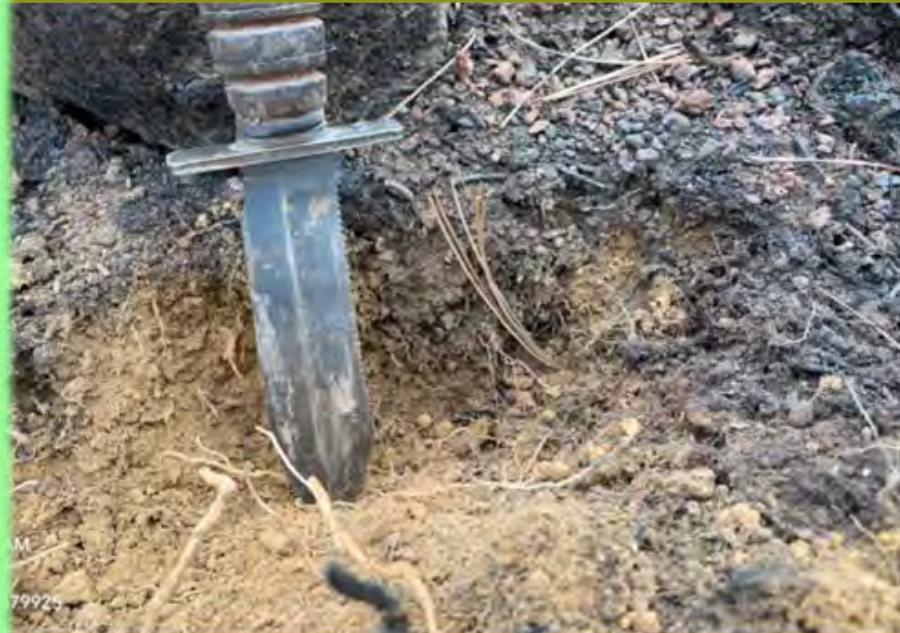
Moderate Soil Burn Severity

- Soil structure weakened.
- Roots dry and brittle or charred

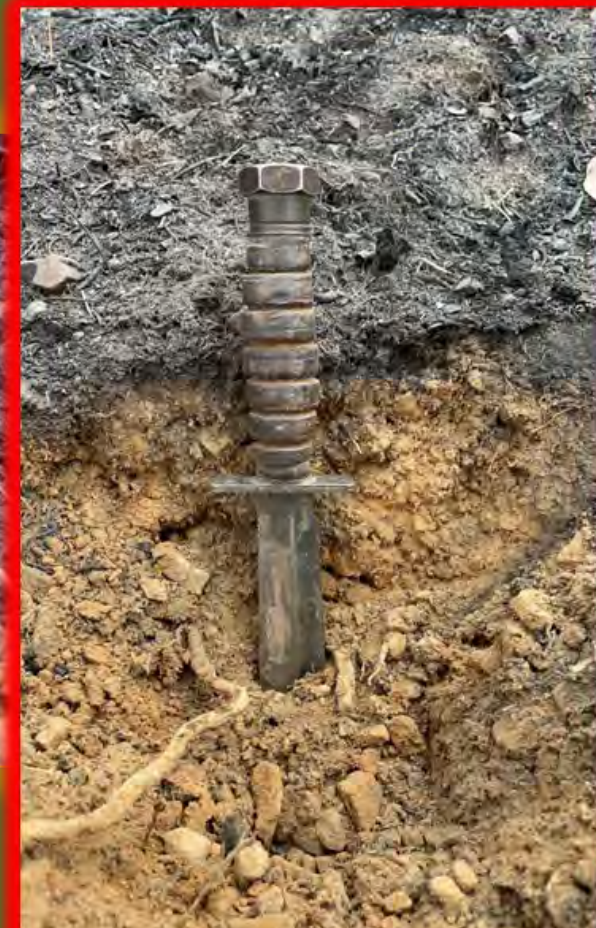
High Soil Burn Severity

- Surface soil structure weakened or destroyed.
- Roots charred or consumed

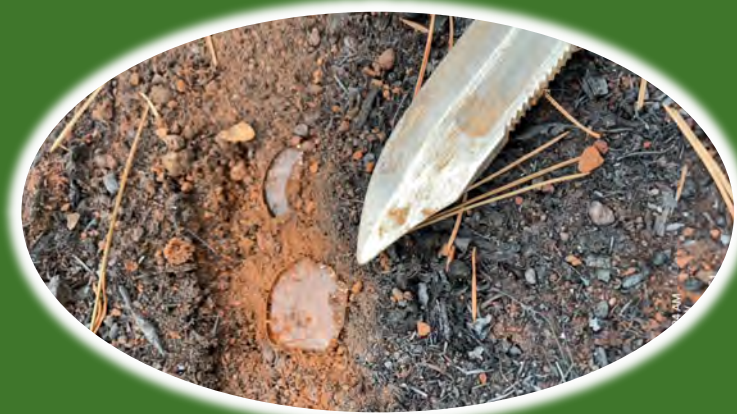
Water Repellent Soil

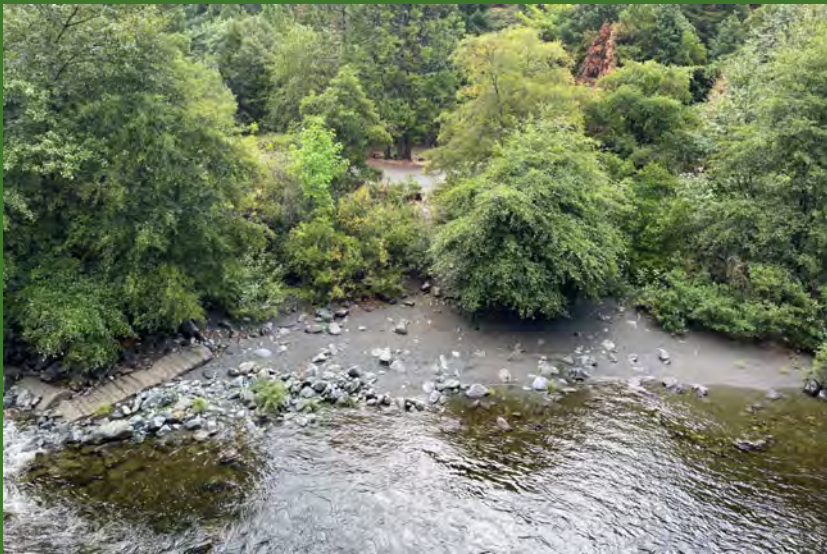
Madrona River Access Site

- Human life and safety
 - Rain events can yield flashy water and debris flows, with sudden instream flow rises in the Smith River and its tributaries.

- Warning Sign Purchase and Installation
 - River access sites, including popular dispersed camping sites

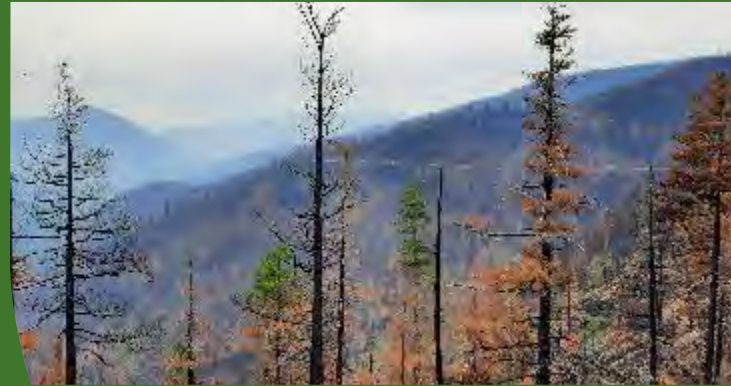
Old Gasquet Toll Road

- Road Loss
 - Rain events creating high erosion potential to block culverts leading to road failure
- Human life and safety
 - Rain events putting debris on the road leading to closures, destroyed roads, and potential for human loss
 - Hazard trees along roads

Treatment	Units	# of Units
R1. Storm Proofing	Miles	44.9
R1. Clear Culvert Inlet Basin	Each	9
R2.a Drainage Dip (10CY Riprap)	Each	36
R3. Storm Inspection & Response	Miles	23.2
R3. Storm Response w/ Heavy Equipment	Each	4
R5. Critical Dip	Each	2
R6. Culvert Mod – Riser Pipe	Each	46
R13. Shoulder Burnout Repair	Each	55

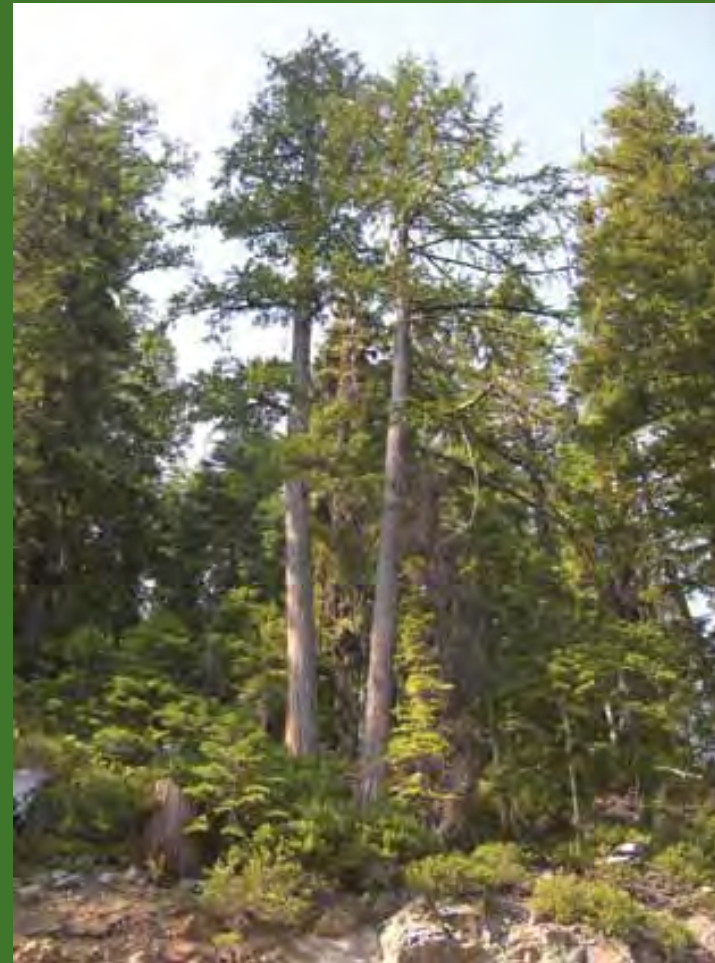
Mature healthy Port Orford cedar

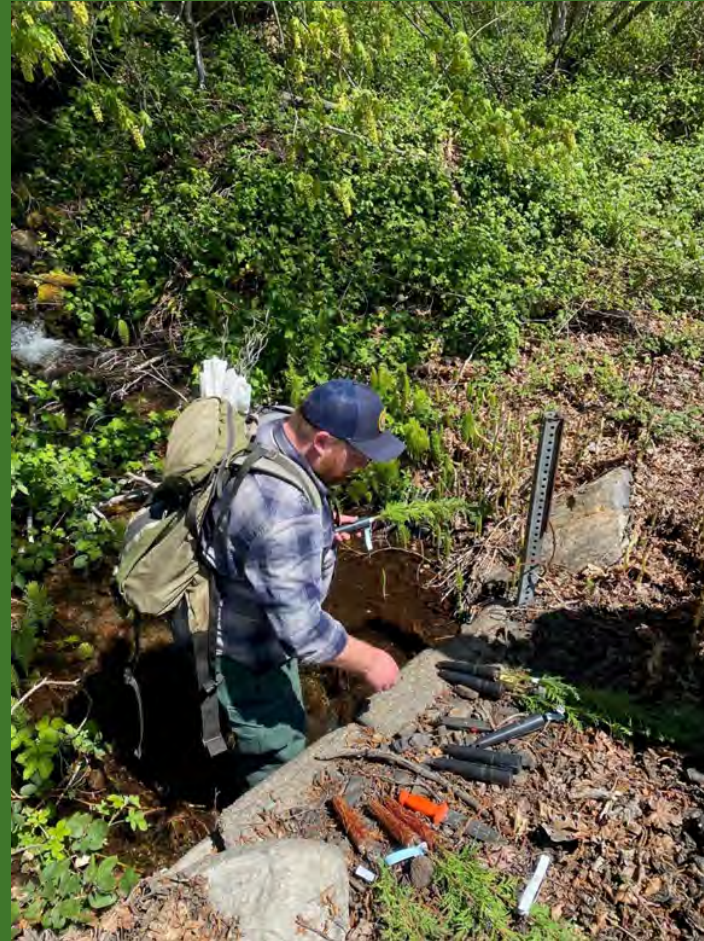
Testing using bait trees

- BAER Early Detection Rapid Response EDRR – invasive noxious weeds
- P1b Suppression Disturbance EDRR - invasive noxious weeds
- P3 Other Plant Treatments - Plant Pathogen Testing/Monitoring/Treatments

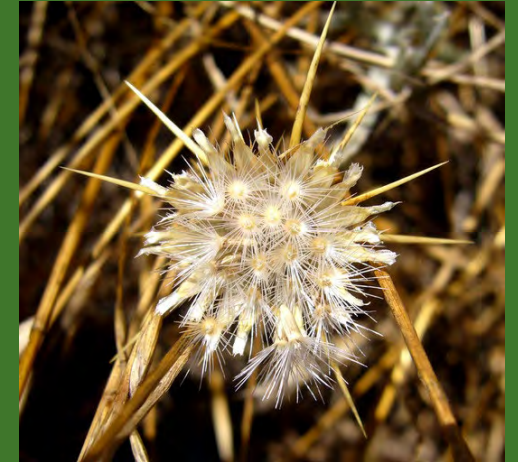
yellow star-thistle seeds

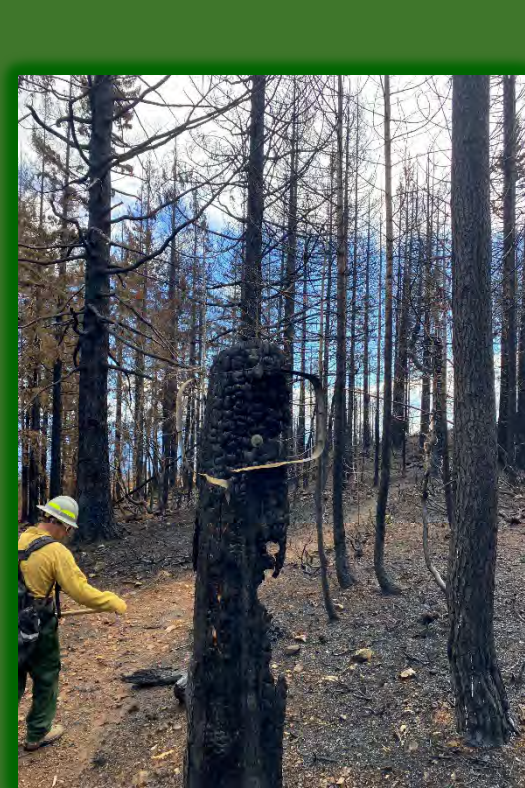
Historic trails and road features

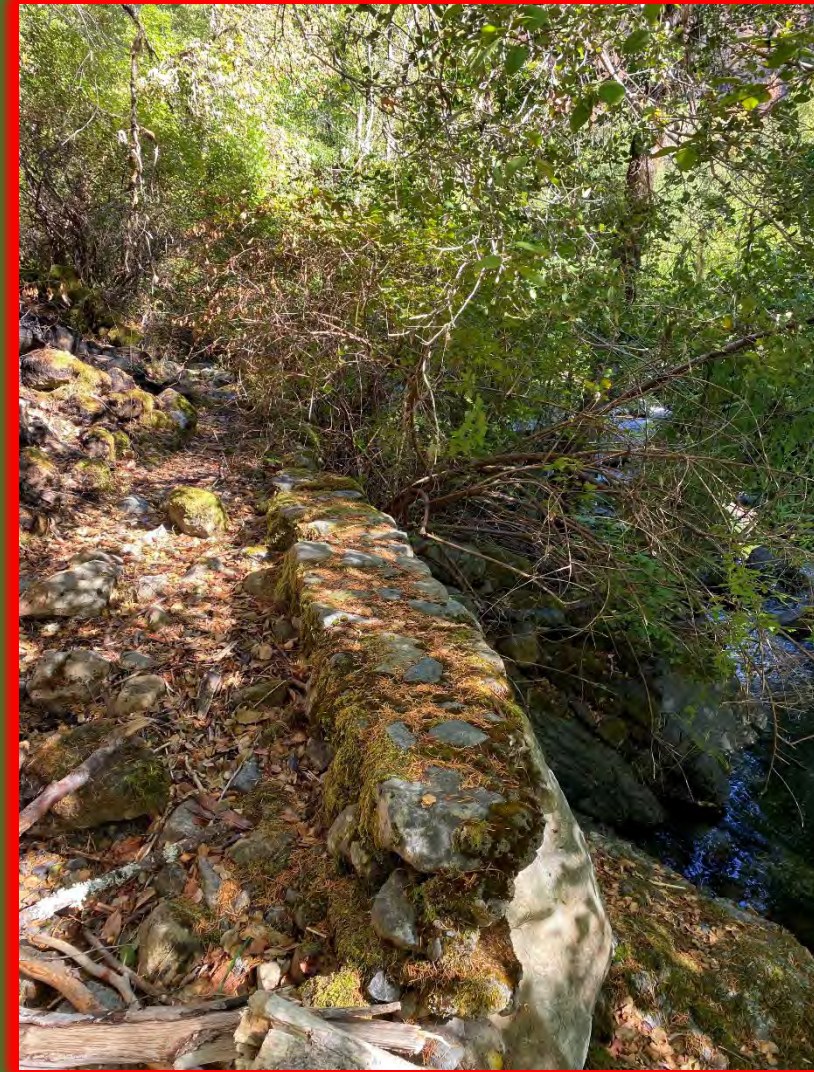
Burned
Hazard
Trees
around
historic
features

Hydrological
models
project
accelerated
erosion of
historic
masonry
along stream
(historic
swimming
area)

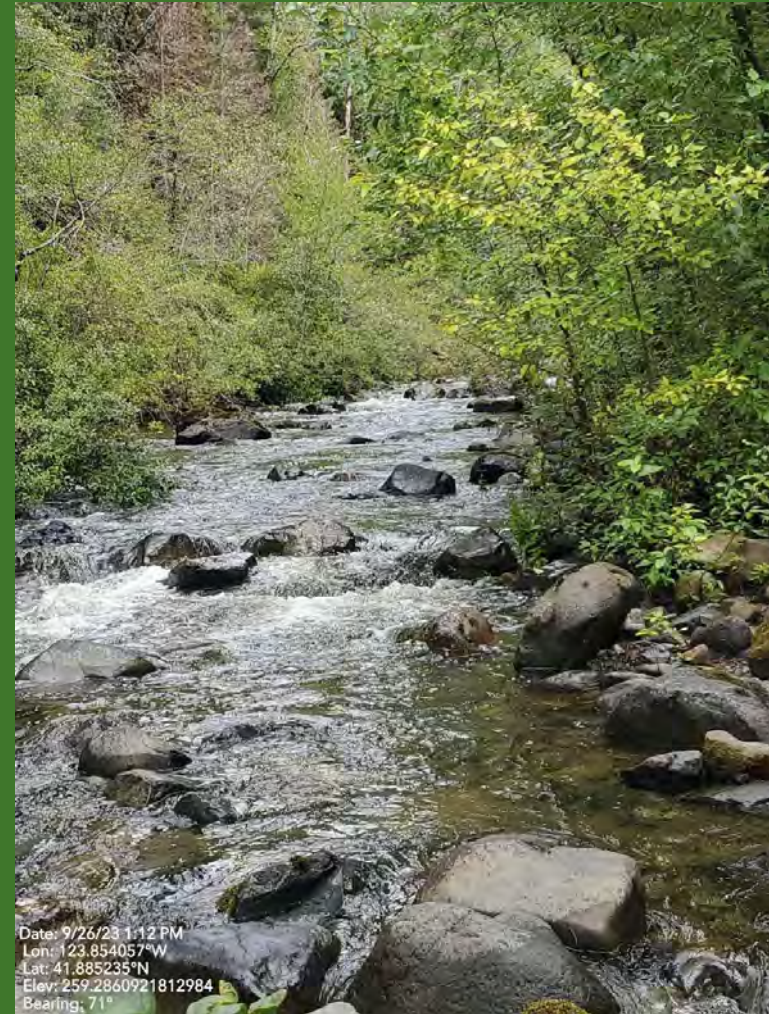
- Warming water temps and leaf litter reduction as 43% of Riparian Reserves burned had >50% basal area mortality
- Increases in expected peak flows and associated sediment delivery in some catchments
- High potential for debris flows in some areas

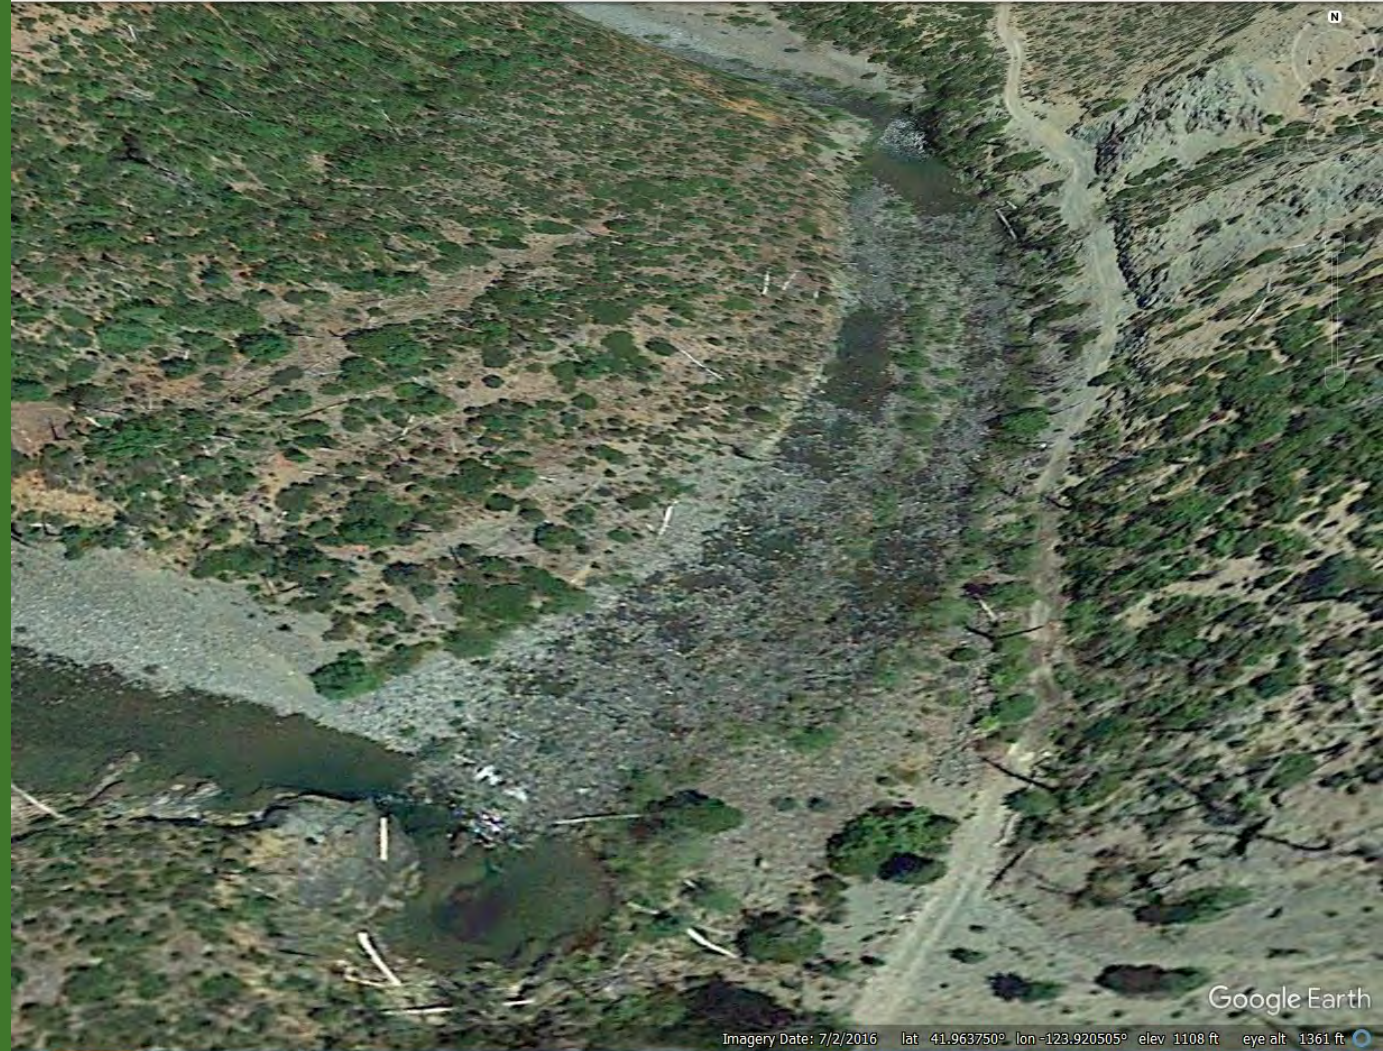
Diamond Creek location where wood could be added

- Wood additions to Diamond Creek
- Remove/upsized certain culverts
- Mitigate cannabis cultivation sites
- Remove wood from burnt bridges
- Soil stabilization/planting if prescribed by other specialists

No BAER treatments recommended

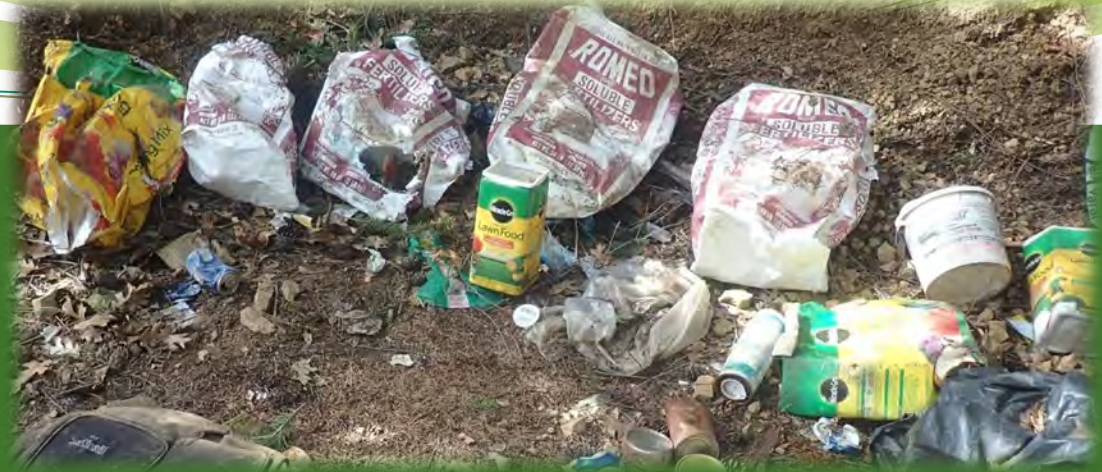
- 40 in Pacific Marten Suitable Habitat
 - 3 in Northern Spotted Owl Core Habitat
 - 24 in Coho Salmon Occupied Waters
-
- 100% Sites in R5 have Pesticides
 - 80% have Banned Pesticide
-
- Fire Exacerbates the Problem
 - Flames Compromise Containment
 - Hazmat Containment gets Liberated
-
- SBS Exposure & Transport
 - Erosion transports
 - Footprint Increases
 - Soils & Water Contaminated

Fertilizers, Batteries Pesticide Sprayers

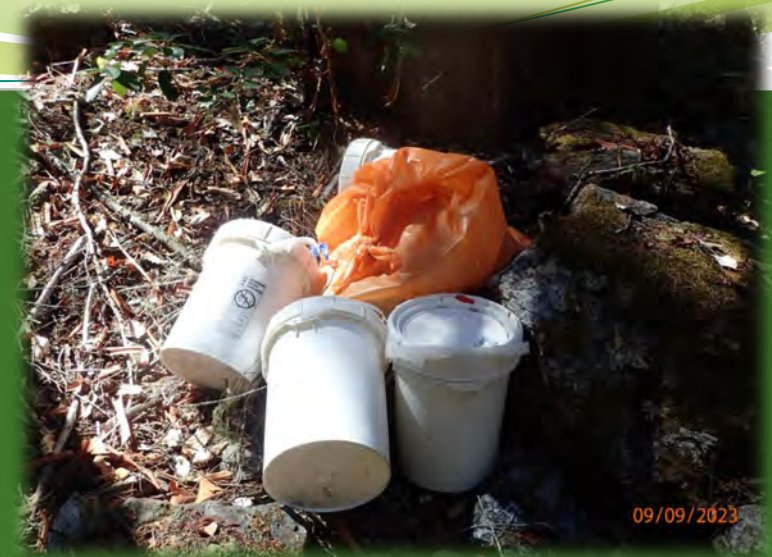
Class X supersacks and Class X buckets

- Hazmat Stabilization
 - LEI hazmat team or contractors stabilize, contain, mitigate, & transport for disposal
- 24 Sites Selected to Prioritize
 - Coho salmon drainages
 - Grouped sites for greatest number & least amount of days
- Multiple Benefits from Removal of Hazmat
 - 100% Owl core habitat improved
 - 16,000 acres Marten habitat improved
 - 16,515 acres of recreation, hunting & gathering improved
 - Public health & safety improved
