Liaison Update #4:

OES Report # 22-2410: Updated 5/23/22

Name of Incident: Smith River Incident

Product details: Asphalt Binder

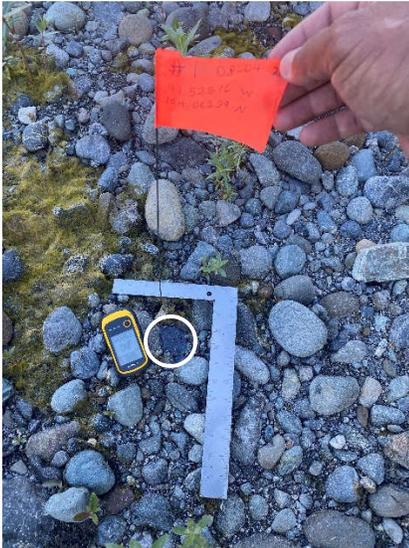
Ancon Services continues to recover shoreline oil, they are now working downriver of the 101 bridge near the estuary and continue to find and flag product for removal (see picture to the left) A tribal representative will be present before they remove oil in this area. In the picture, the tarball is outlined in white for ease in reference.

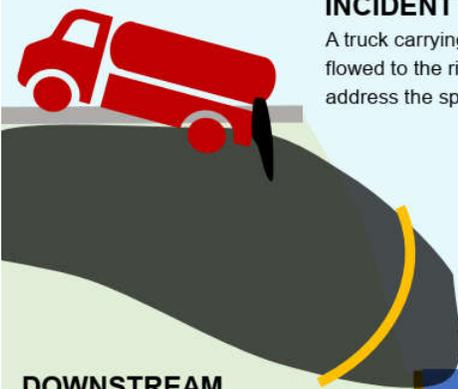
Smith River Incident – Oil Fate and Strategies

A truck carrying asphalt binder crashed, spilling the contents onto the highway. The product then flowed to the riverbank and into the Smith River. Different strategies are being implemented to address the spill site and product that is appearing on shorelines downstream.

In the cold water, the product solidified and sunk. In solid form, the product remained hidden from view in the deeper portions of the river. A storm increased flow and turbulence within the water which remobilized the solid product and broke it into smaller pieces. The current then carried these small pieces (tarballs) down river.

The product quickly solidified in the cold weather along the shoreline. Earthen dams were constructed to impede flow of the material to the river and responders began to remove product from the shoreline. Warm weather increased the stickiness of the product on the shoreline, but no sheen has been observed at this time. Strategies to remove the remaining product from the shoreline will prioritize responder safety and attempt to minimize potential erosion impacts.

As the tarballs moved downstream, turbulence within the river broke up the product into smaller tar balls, which were deposited onto shorelines. After the storm, flows reduced, and air temperatures increased. Tar balls deposited on the shorelines were heated by the warm weather and turned sticky. Responders are conducting Shoreline Cleanup Assessments to determine shoreline oiling and appropriate cleanup methods. The Unified Command is also evaluating safe and effective strategies for assessing the extent of the sunken oil and methods for potentially removing it from the river bottom.

Response teams are assessing the impacts on foot and by boat to locate tarballs/tar patties and recommend cleanup strategies. Following cleanup operations, the SCAT teams return to each area to verify attainment of the cleanup objectives. The map attached to the bottom of this update shows the spill area from the point of the accident to the downstream-most observation of oil with representative photos collected by the SCAT teams of the observed oiling. The graphic above outlines the general oil fate and strategies for this incident.
